Central Saanich Municipal Building

Building Code Compliance & Accessibility

Building Assessment Report

2025-05-15

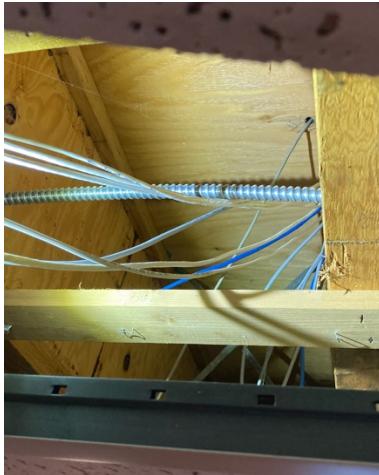
Existing fire resistance ratings of assemblies and separations of suites were either deficient, or not present (no continuous drywall in ceilings, multiple openings/penetrations through assemblies). Where existing fire separations between suites do exist, they cannot be confirmed to meet the ratings (1&2 hours depending on location). Existing historic construction within the building also cannot be assumed to meet the fire resistance ratings (1/2" drywall of unspecified type). The proposed renovation including abatement in the building would additionally eliminate any/all existing fire separations and fire rating of assemblies through removal of the existing drywall. It should be assumed that all required fire separations and fire resistance ratings throughout the building would need to be constructed as new and include new Type X Gypsum Wall Board to all supporting structural walls, suite dividing walls, and ceilings.

Existing Assemblies Lack Required Fire Resistance Ratings

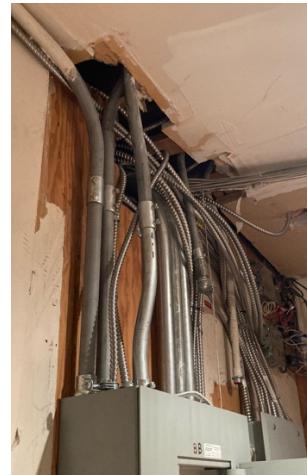
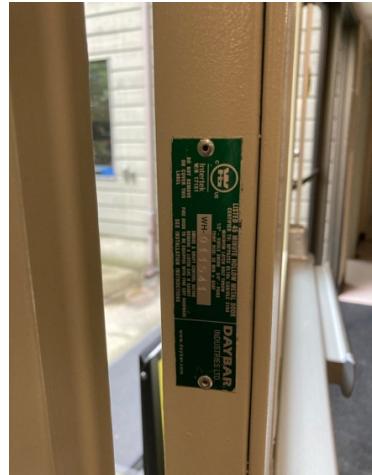
Existing 45min Doors

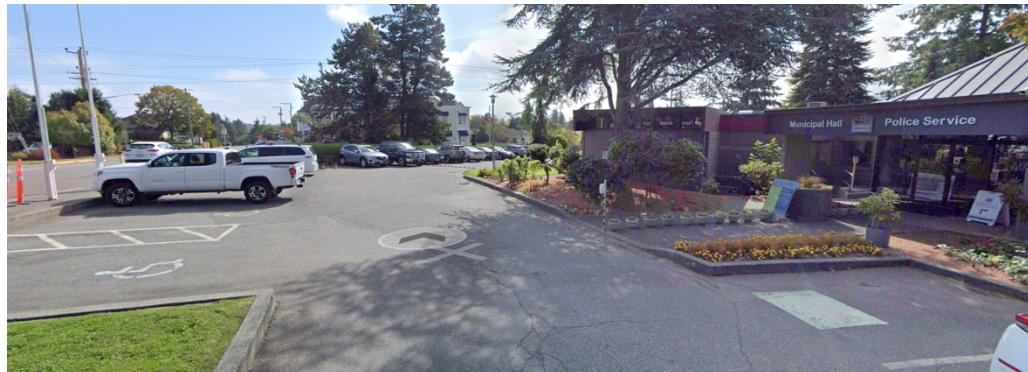
The building does not meet current building code intent regarding accessibility. In particular, the provision of an accessible path of travel to all pedestrian entrances and connecting to a public thoroughfare (2024 BCBC 3.8.2.5). The intent being to limit the probability that people using a manual wheelchair or other manual mobility assistance device will not be able to enter a suite without the assistance of another person. The existing connections to the public sidewalks requires pedestrians and wheelchair users to traverse the sloped vehicular driveway not conforming to the requirements of an accessible ramp and cross behind parked cars with no marked crossing provided.

Existing Exterior Main Floor Access

A proposed design solution is to provide a code compliant walkway connecting to the sidewalk along Mount Newton Cross Road including a marked crossing over the drive aisle. Some reconfiguration of the existing parking and landscaping would be required. Access from the parking area itself is provided by a curb ramp which should be upgraded to include tactile attention indicators now required by code to warn users they are crossing into a vehicle aisle.

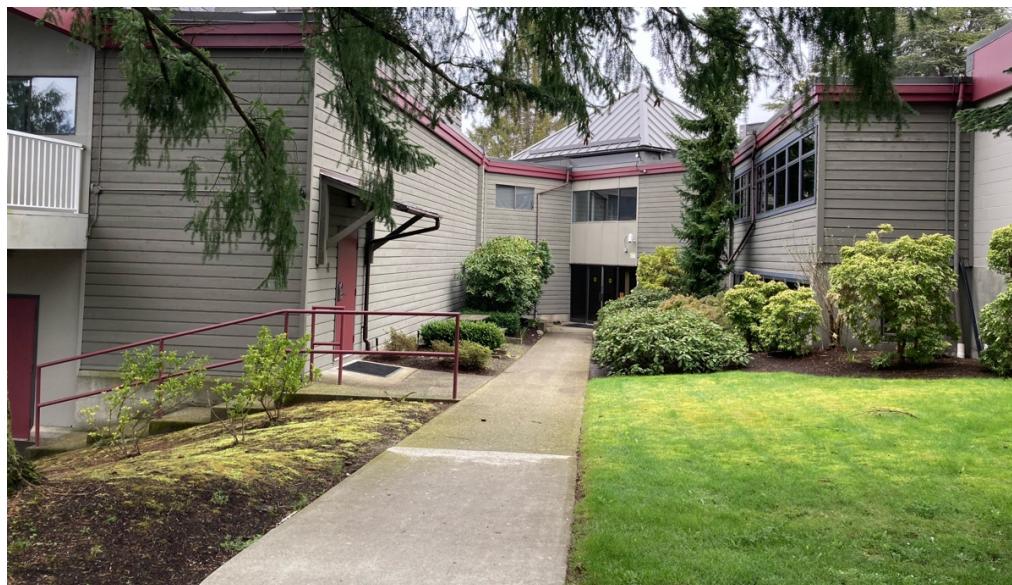
Exterior accessible approach from the rear parking lot is provided by an existing sloped walkway. The existing walkway is not required to be a ramp with handrails, but would benefit from the addition of cane detectable edge protection to the surrounding landscaping, and the addition of tactile attention indicators at the transition to the drive aisle (required building code).

Existing Lower Floor Access

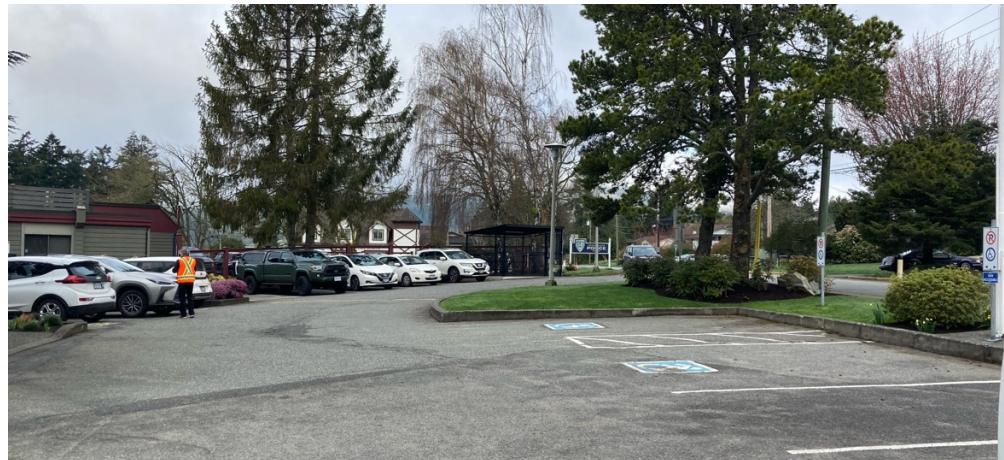
Two accessible parking stalls are provided near the front entry for public use. The parking stalls appear to be sized adequately and are provided with a shared access aisle and the code required identification signs. However, the stalls require users to cross into the vehicle path of travel as no direct accessible aisle is provided to get to the entrance. A marked crossing connecting the access aisle between the accessible stalls and the curb ramp to the entry would be a possible way to resolve the deficiency and serve a dual purpose with the need to provide an accessible pedestrian walkway connection to the public sidewalk. Ideally the accessible parking stall would be relocated to directly outside the entry and not require crossing the drive aisle (i.e., swap locations with the existing electric vehicle charging stalls).

Existing Accessible Stalls

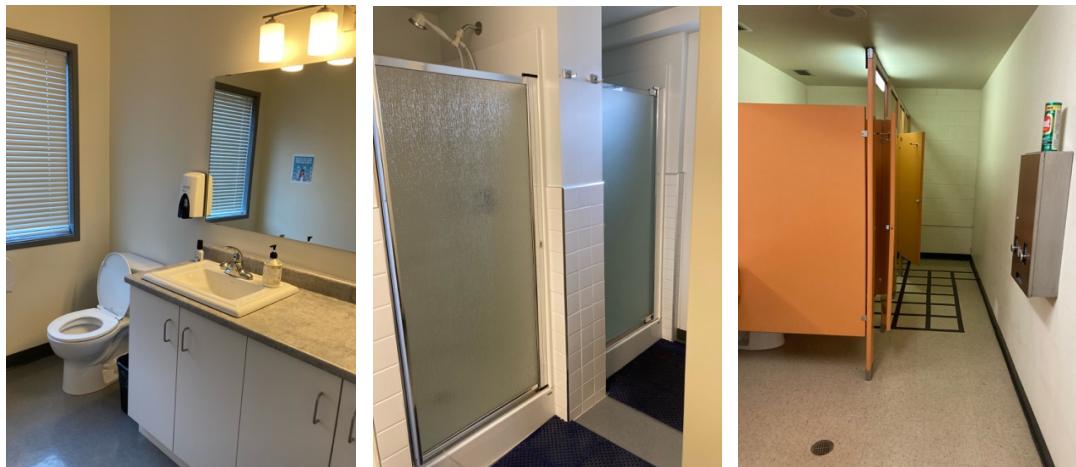
Examples of Existing Staff Washroom Facilities

Accessible washroom facilities should be available for staff (and public) on each floor, and the provided staff washrooms do not meet accessible requirements. The main shortcoming of the existing washroom layouts is size – current accessible standards have been increased in the current code and include requirements for clear areas at sinks, both sides of entry doors, and provision of larger accessible stalls that are not provided in the existing building and could not practically be accommodated in the existing building layout.

The proposed major upgrade of the building would include replacement of plumbing systems and reconfiguring of interior spaces including size and location of washroom facilities. To meet current building code requirements for accessible design and allow for desired adjacencies to a newly reconfigured floor plan, it would be required to remove all existing washroom facilities in the building and reconstruct as new. The District has included a change to gender neutral facilities as part of their provided programming for the facility which further reinforces the need to re-plan and reconstruct the washrooms as new.

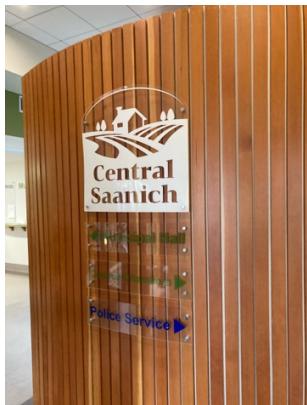
Directional signage in the lobby is not of a high standard and is plexiglass, resulting in reduced legibility due to glare. It is recommended that building directional signage be upgraded in line with accessibility recommendations of CSA B651:23 including use of glare-free surfaces.

Existing Lobby Signage

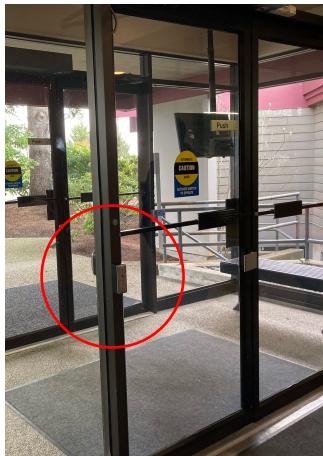
Where provided, the current door operators installed do not meet current code requirements for design and range of operation. Door operators required under code need to be operable from a height between 150 mm and 300 mm as well as between 900 mm and 1100 mm above the floor – this necessitates the installation of two operator controls in each given location or the use of a full-length type operator as shown below.

Example Existing Powered Door

Upgrading of the existing door operators would not typically be mandatory, but replacement will be required as the proposed renovation is replacing existing doors and walls where these operators exist. Addition of new operators at all entrances, to all accessible washrooms, and interior doors that are part of the accessible exit paths should be part of any upgrades considered to the existing facilities. We recommend use of full-length style operators as shown above which accommodate a larger range of operating heights.

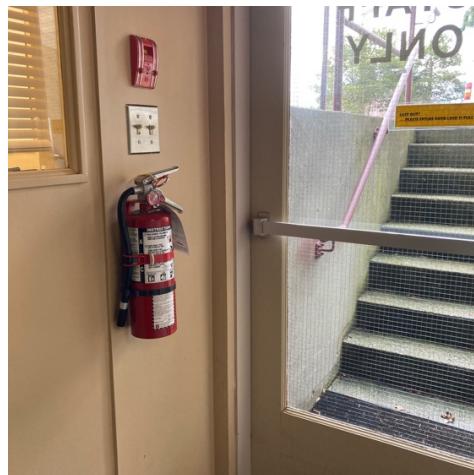
Fire extinguishers are provided throughout the floor areas. Number and location of extinguishers are assumed to be compliant and approved by the local AHJ. Mounting height of the extinguishers appears compliant within the maximum permitted by the National Fire Protection Association (NFPA) (i.e., 5 ft./1.53m to top of extinguisher under 40 lbs). It should be noted that this mounting height, although permitted, can pose difficulties for persons with disabilities, specifically if someone in a wheelchair was required to access the extinguisher. Additionally, the surface mounted extinguishers can also be an obstacle for people who are blind or partially sighted as they project into the path of travel. The existing condition is code compliant but could be improved if mounted slightly lower to be cane detectable.

Existing Extinguisher Wall Mounted

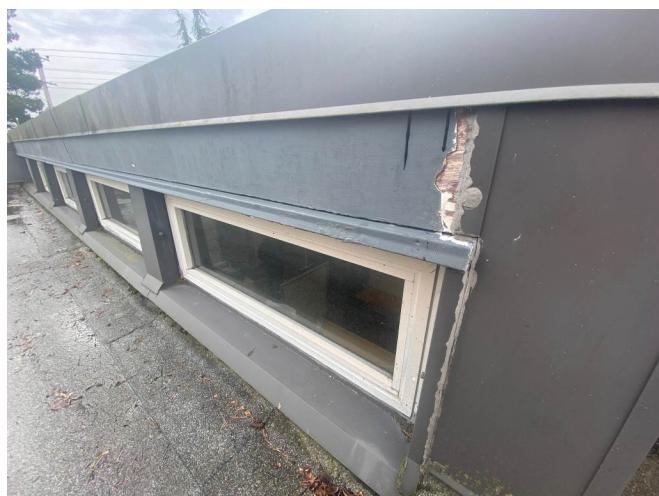
Photo #8: Cladding Failure- Municipal Clerestory

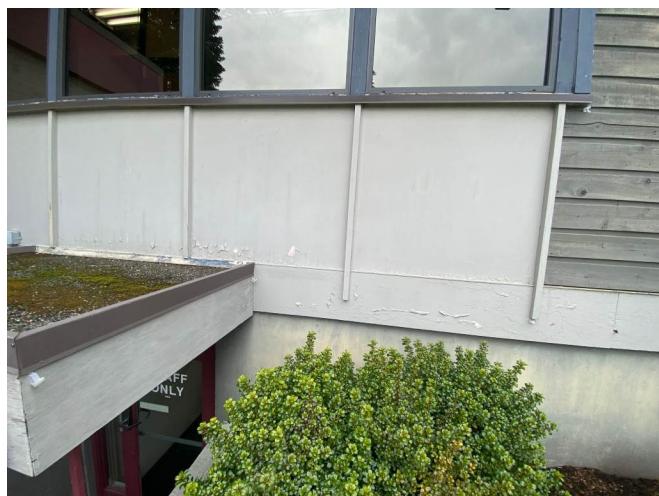
Photo #9: Cladding - Crezon Plywood with Peeling Paint

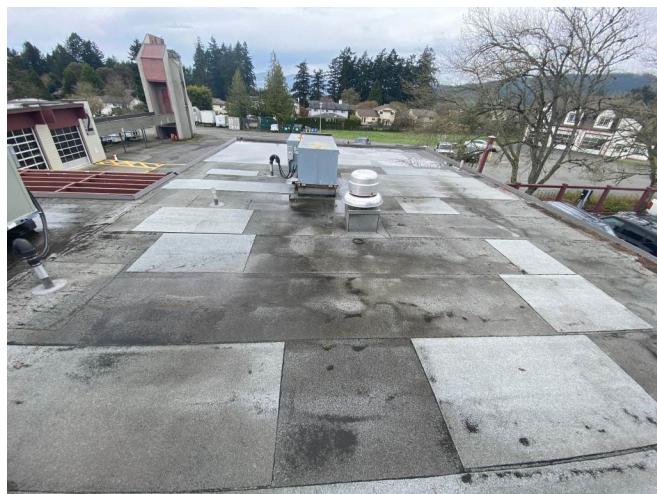
Photo #24: Flat Roofing in Poor Condition - Typical

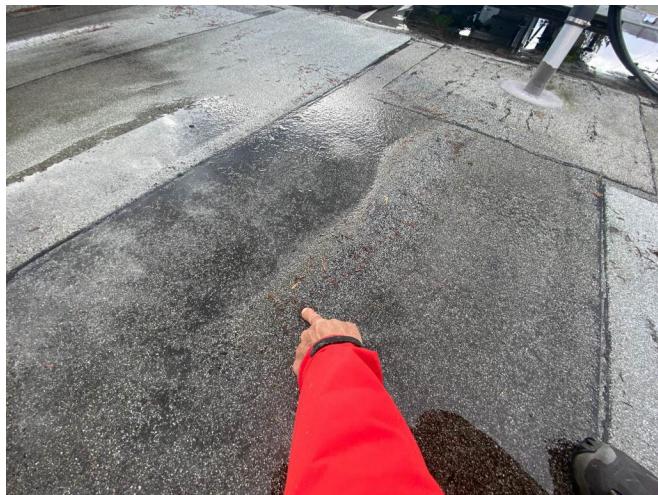
Photo #25: Flat Roofing Blister and Alligator Cracks

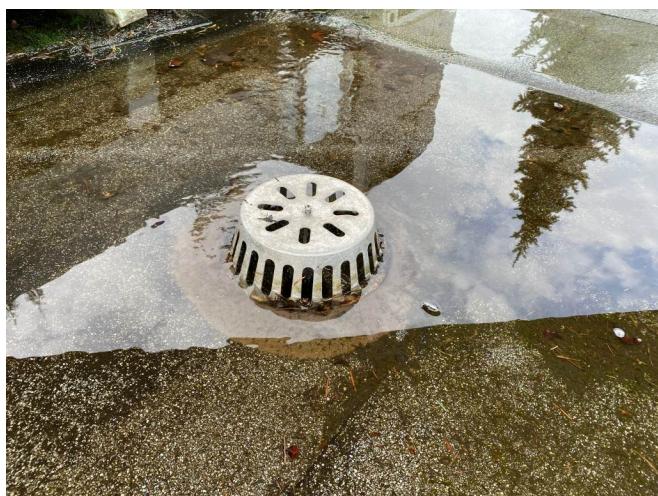
Photo #26: Flat Roofing - Ponding at Area Drain

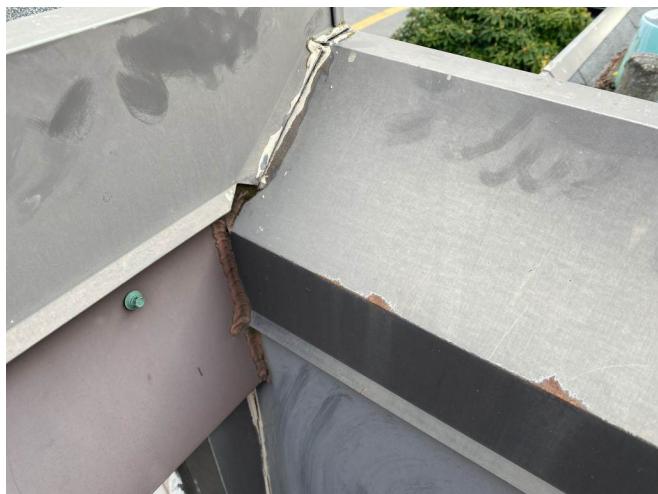
Photo #27: Parapet Metal Flashing- Sealant Failure

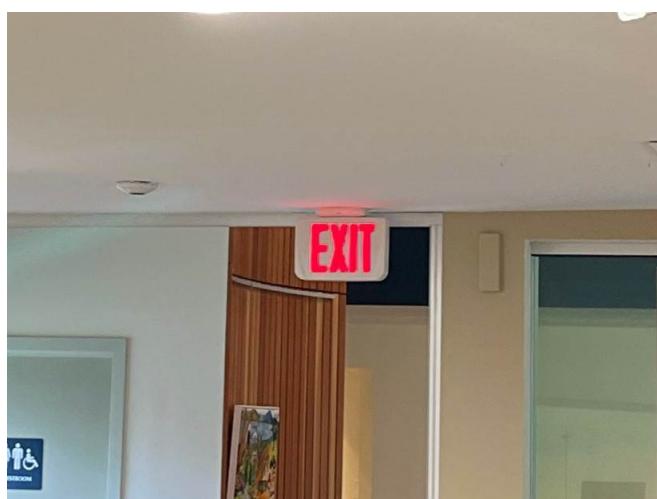
Existing exit signage includes the older 'EXIT' style illuminated text that does not meet current code requirements. The recommendation is that these be replaced with newer graphical symbol 'running man' style exit signage illuminated in green.

Photo #33: Exit Signs - Old Type

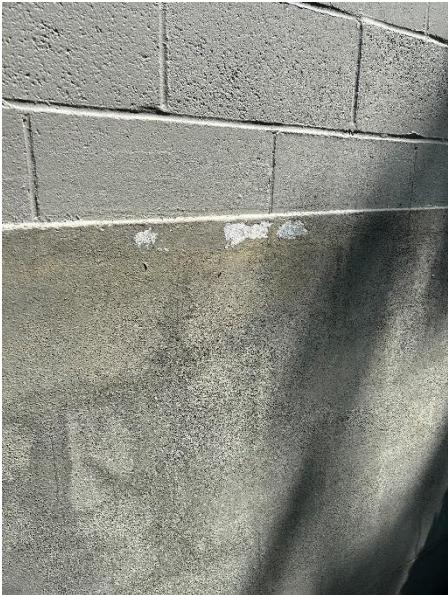
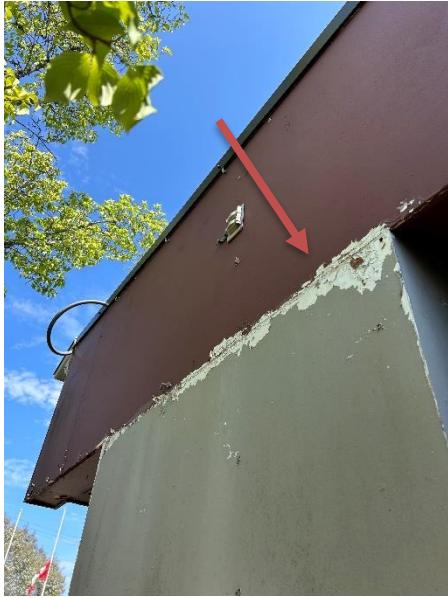
<p>Sample: 48738 – Pb9 Location: Exterior Municipal Hall Siding Description: Taupe Paint Lead Content: 3700μg/g</p>	<p>Sample: 48738 – Pb10 Location: Exterior Police Department Wood Siding Description: Taupe Paint Lead Content: 4130μg/g*</p>

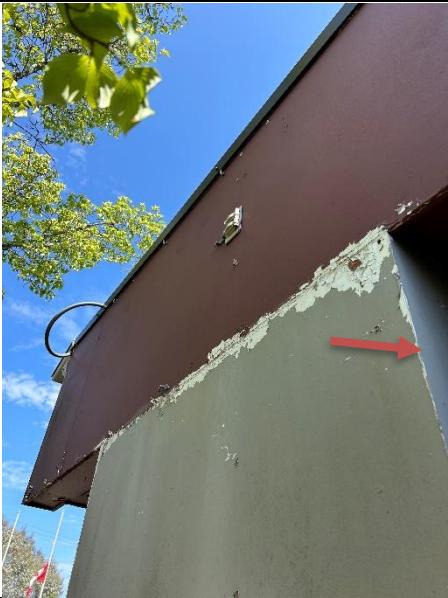
Sample: 48738 – Pb12
Location: Municipal Hall Front Entry –
Upper
Description: Red/Taupe/White Paint
Lead Content: **10900 $\mu\text{g/g}$**
