Central Saanich Municipal Building

Building Code Compliance & Accessibility

Building Assessment Report

2025-05-15

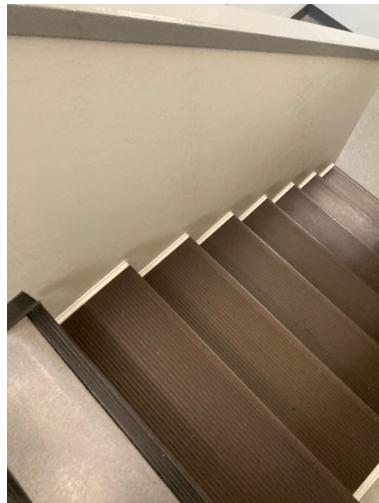
The existing exit stair design does not meet current building code design standards. Current code requires the installation of tactile attention indicators at the top of each flight of stair as well as colour contrasting strips at the edge of each stair tread not uniformly present as existing. Design of handrails on exit stairs is also not uniform or necessarily conforming to current code design requirements. Existing exit stairs within the building vary in width, as well as provided sizes of landings and clearances at doors at landings – rise and run were not confirmed but may also not conform to code requirements. Compliance with all aspects of 2024 BCBC will likely require full reconstruction of the existing exit stairs, both for fire separation of the exits, and to meet design accessible/safety features of modern exit stairs.

Example of Existing Exit Stairs

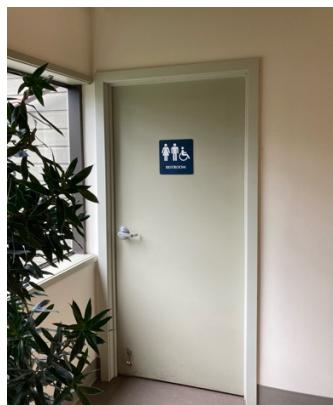
Existing Door Signage

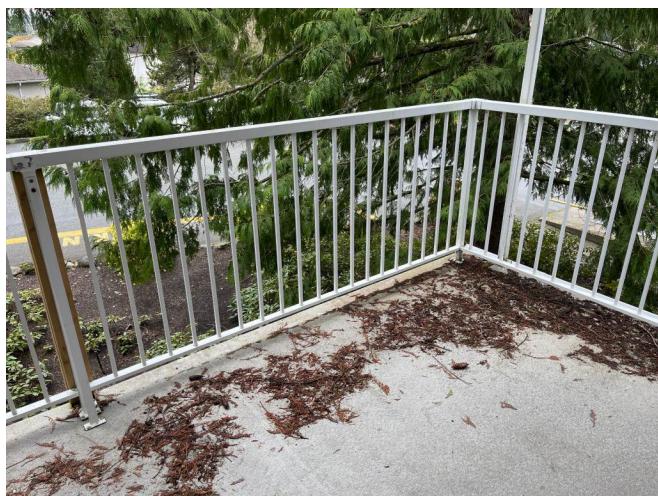
Photo #2: Balcony with Picket Guardrails - Municipal Hall

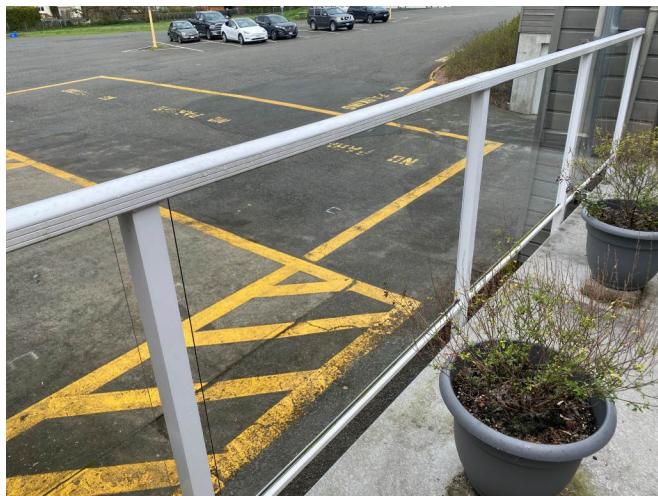
Photo #3: Balcony with Glass Panel Guardrails - Police Balcony

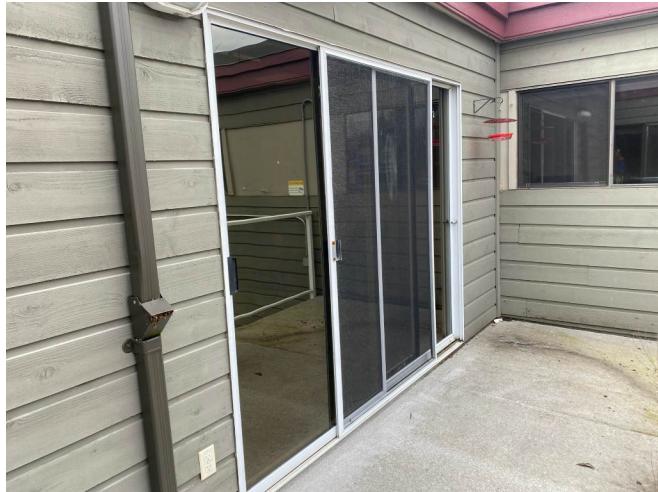
Photo #4: Balcony Sliding Doors - Police Balcony

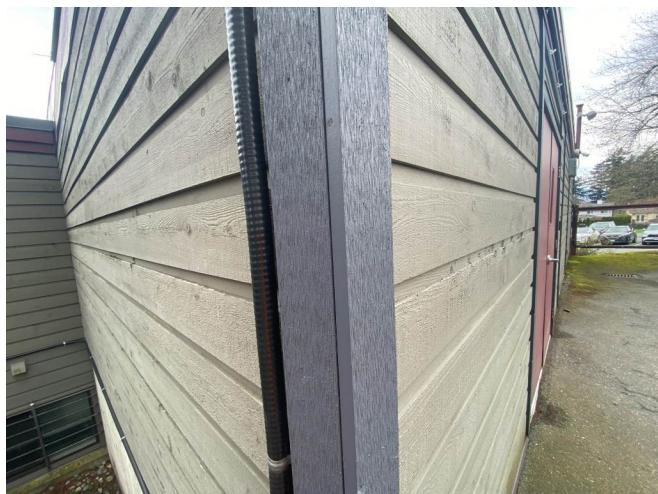
Photo #5: Cladding- Wood Trims at Corners - Typical

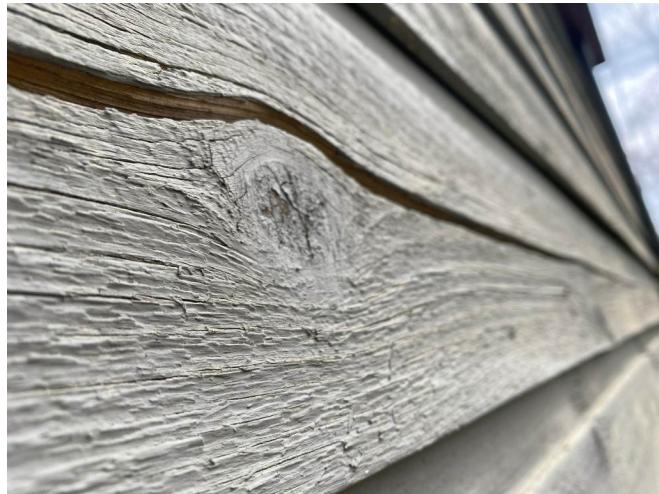
Photo #7: Cladding-Wood Siding - Southeast Weathered

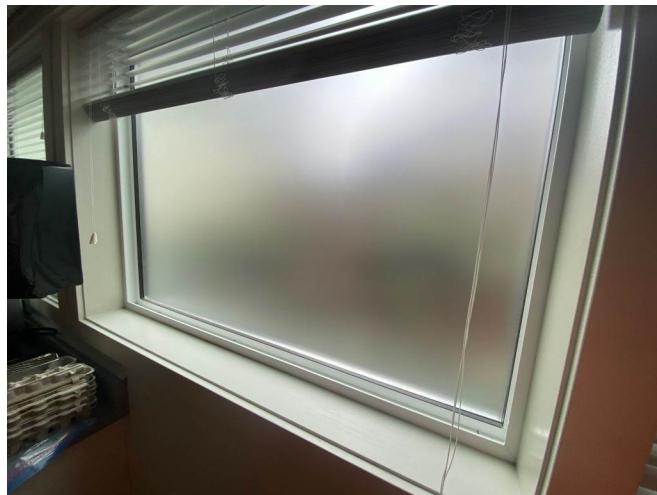
Photo #10: Windows- Double Glazed Vinyl - Typical

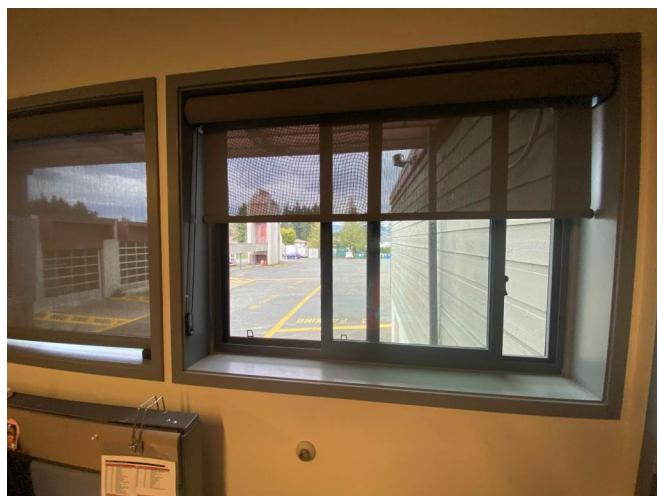
Photo #11: Windows- Double Glazed Aluminum - Typical

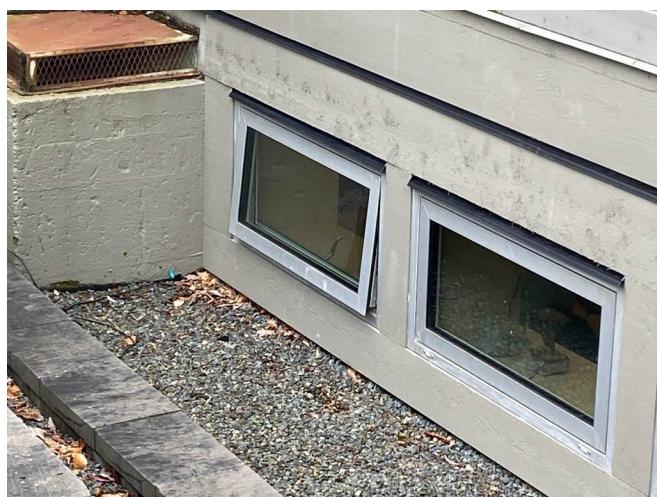
Photo #12: Windows-Newer Aluminum Awning - Typical

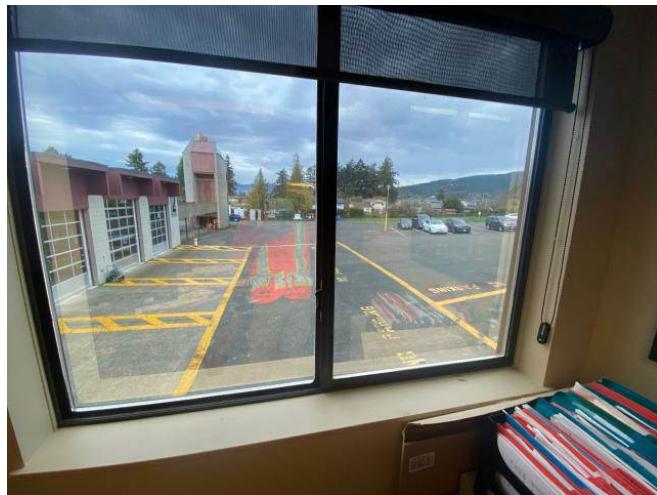
Photo #13: Windows- Old Double Glazed - Typical

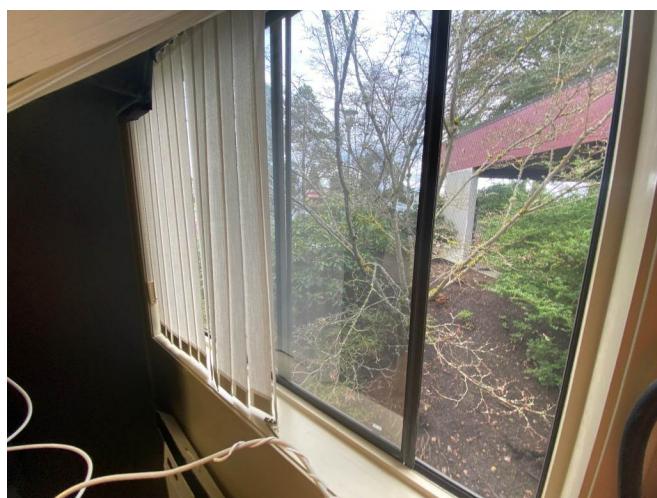
Photo #14: Windows- Oldest Single Glazed Aluminum - Typical

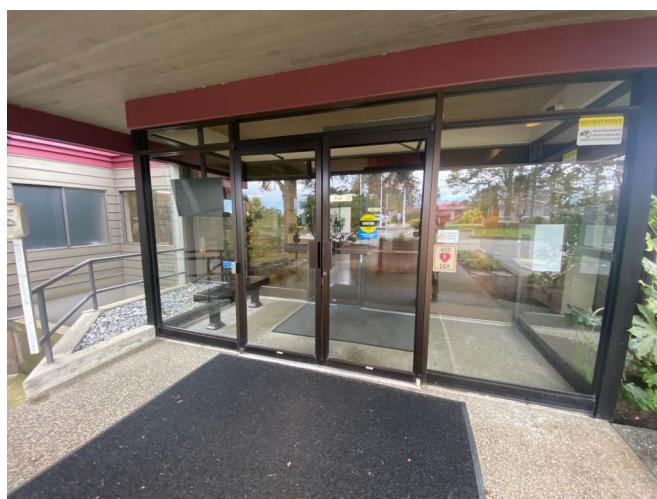
Photo #15: Exterior Door- Aluminum - Main Entrance

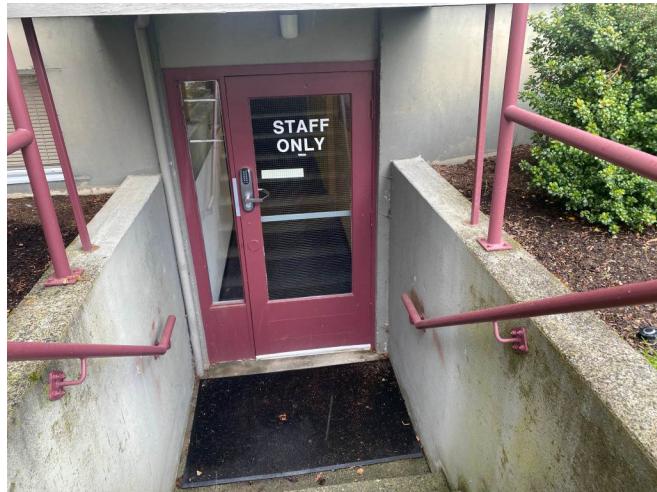
Photo #16: Exterior Wooden Door- Municipal Staff Room

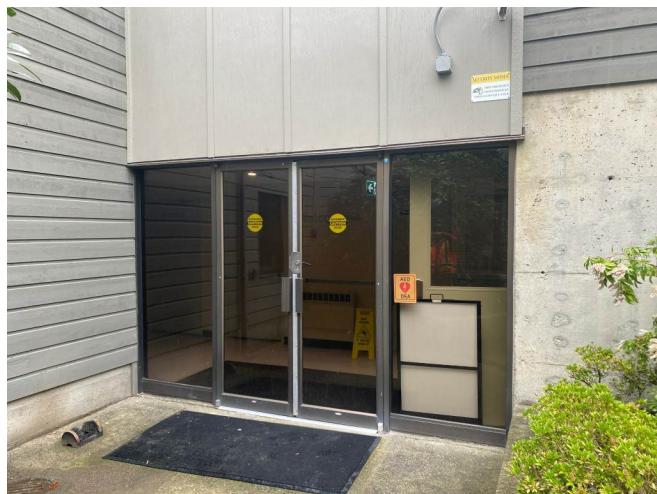
Photo #17: Exterior Door- Aluminum - South Courtyard

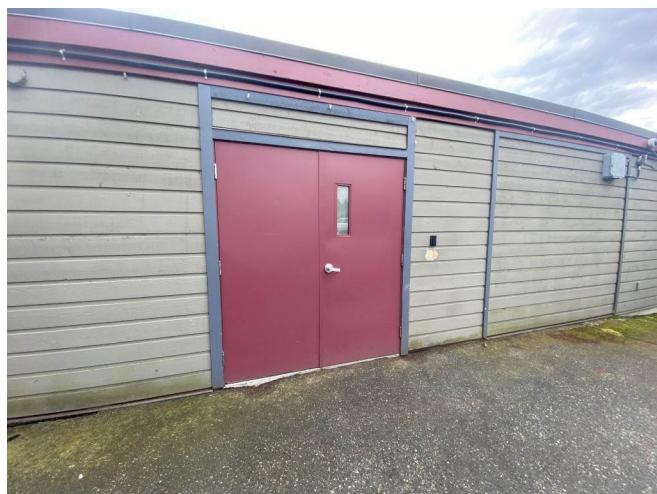
Photo #18: Exterior Double Door - Metal

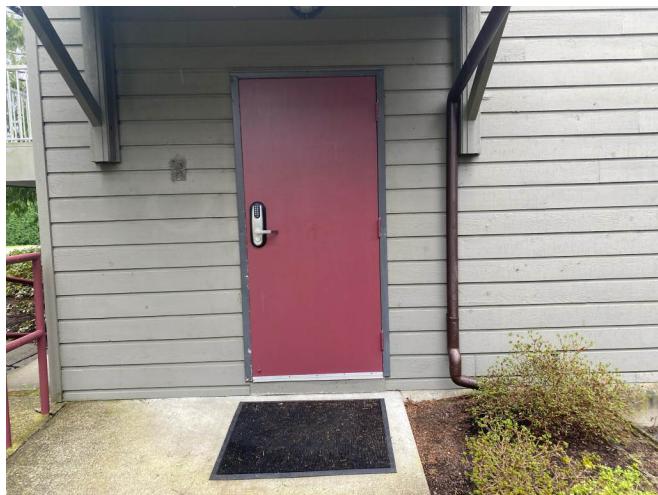
Photo #19: Exterior Single Metal Doors- Typical

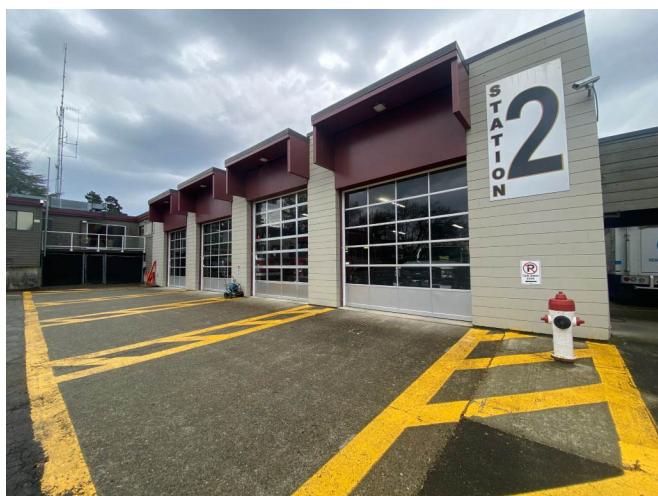
Photo #20: Exterior Doors - Firehall North Overhead Rollup

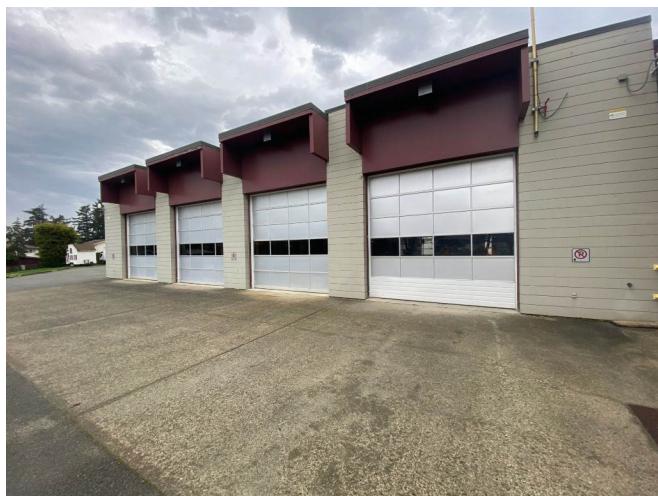
Photo #21: Exterior Doors - Firehall South Overhead Rollup

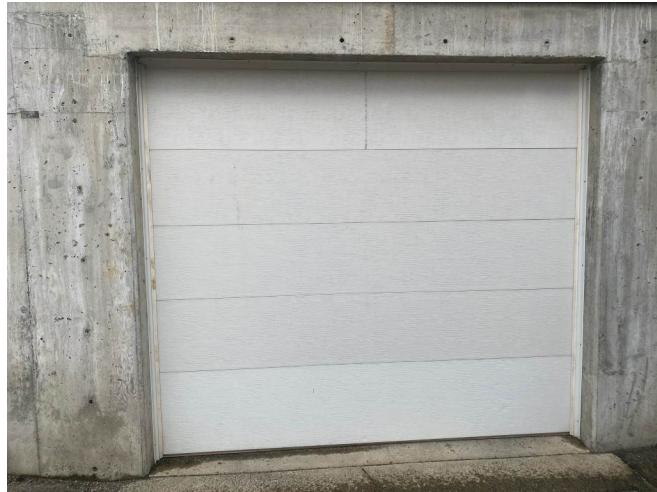
Photo #22: Exterior Doors- Vinyl Rollup

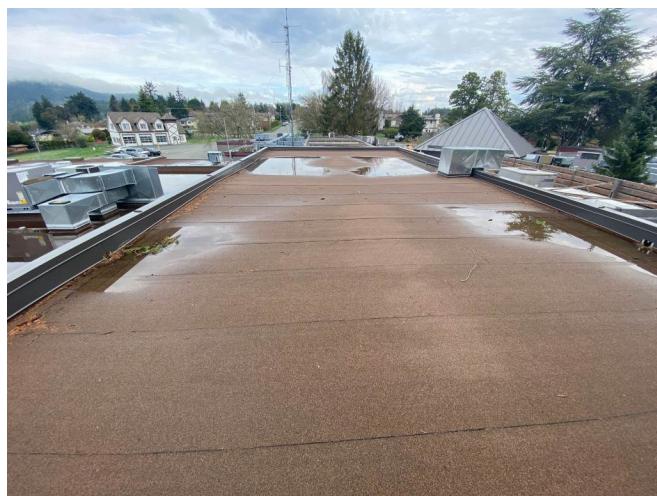
Photo #23: Flat Roofing in Good Condition

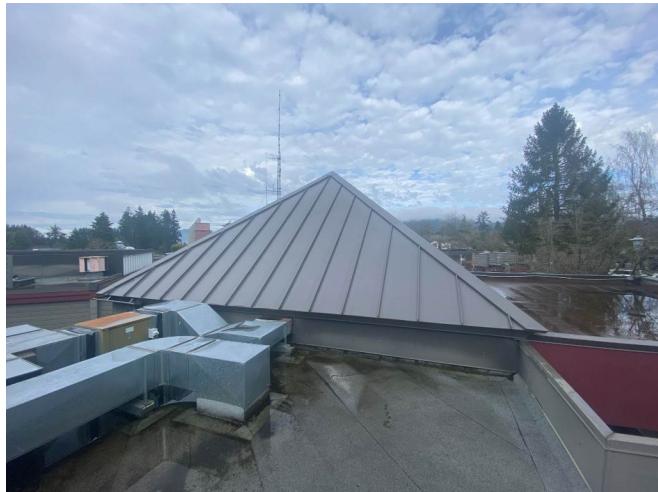
Photo #28: Roofing- Sheet Metal Dome

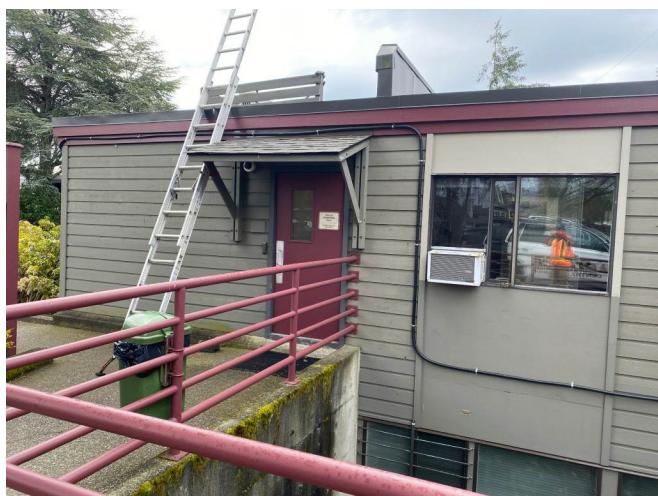
Photo #29: Roofing- Sloped Asphalt Canopy - Typical

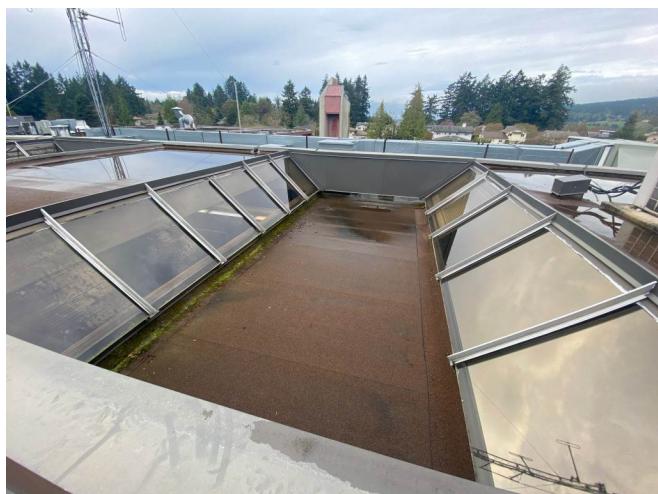
Photo #30: Skylights - Typical

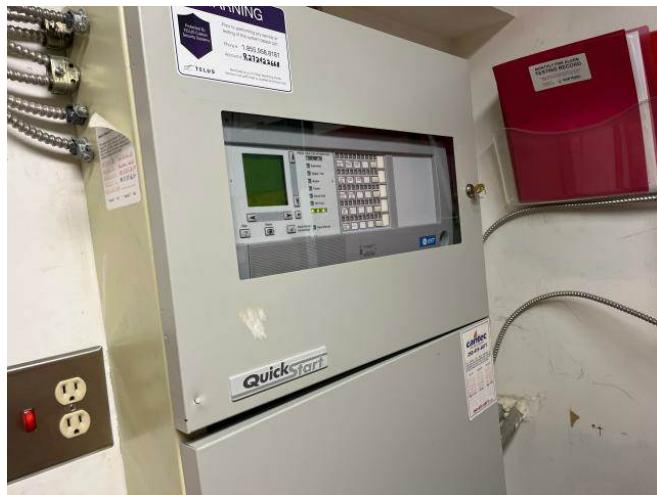
Photo #31: Fire Alarm Panel

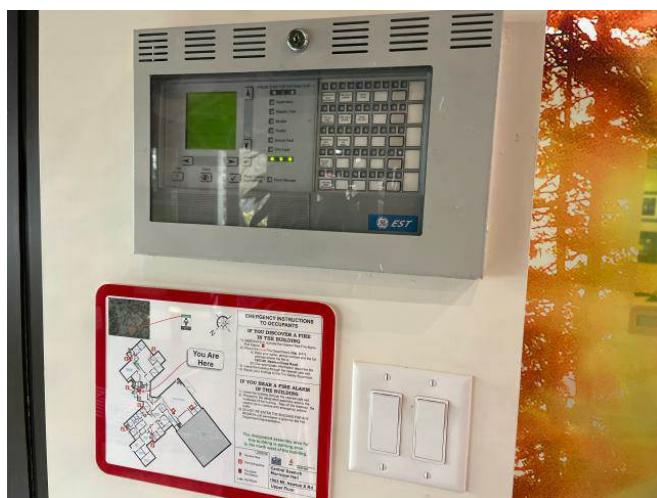
Photo #32: Fire Alarm Annunciator Panel

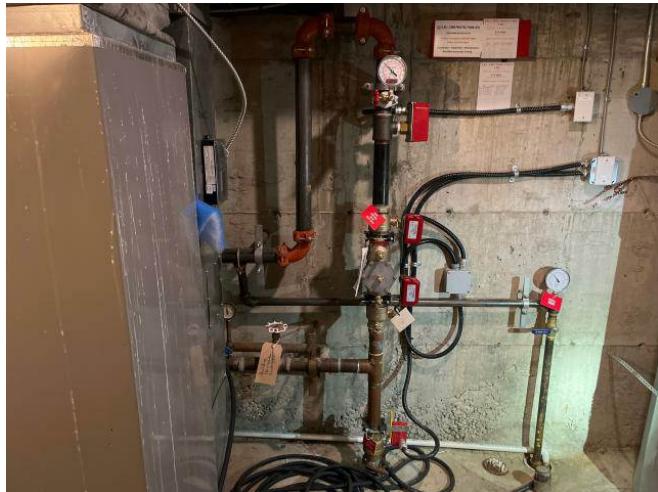
Photo #34: Fire Sprinkler Riser

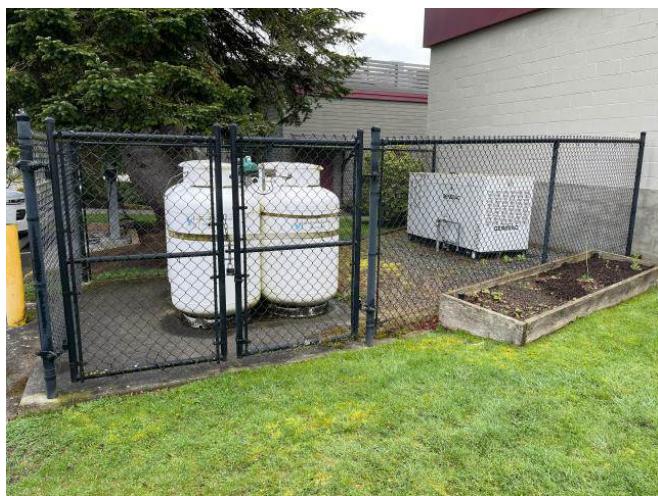
Photo #36: Generator- Propane (Outdoor)

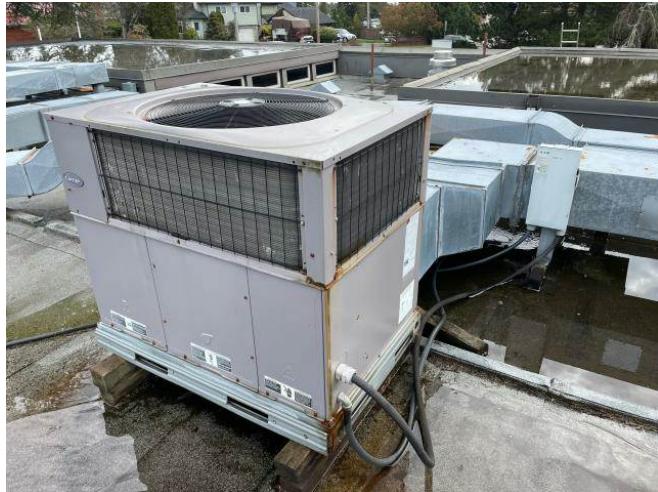
Photo #37: HVAC - Rooftop HP Package Unit- Typical1

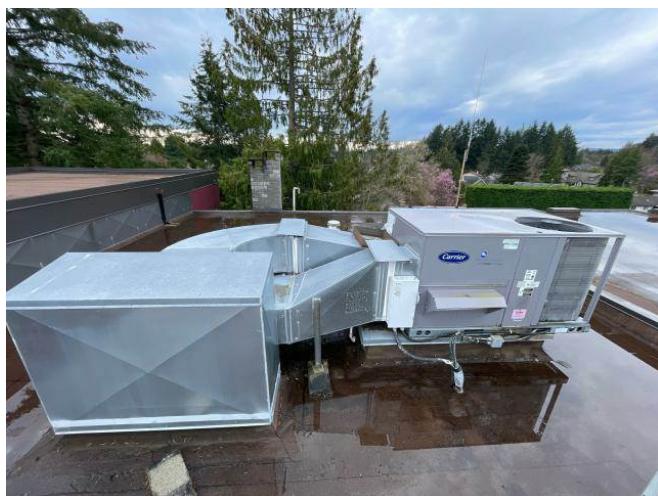
Photo #38: HVAC - Rooftop HP Package Unit- Typical2

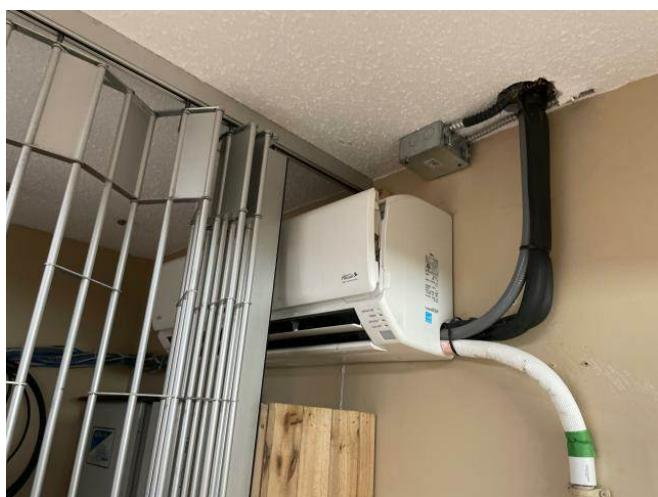
Photo #39: HVAC - Split System Unit- Typical

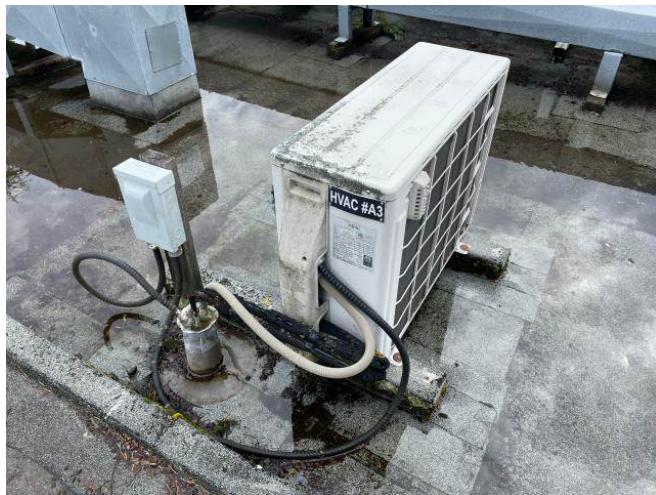
Photo #40: HVAC - Split System HP- Condenser - Typical

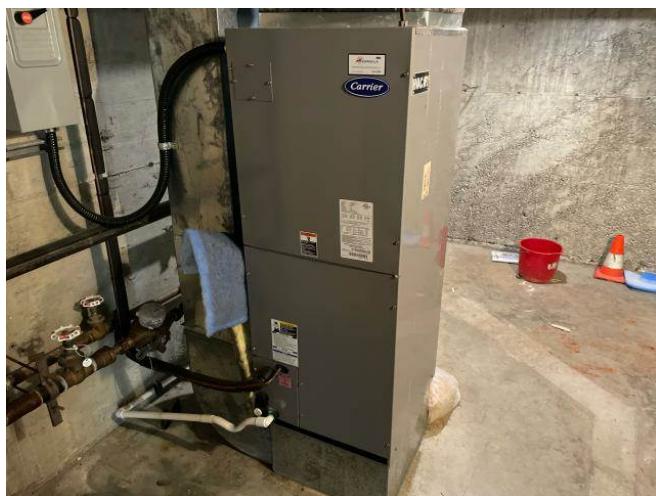
Photo #41: HVAC - Furnace

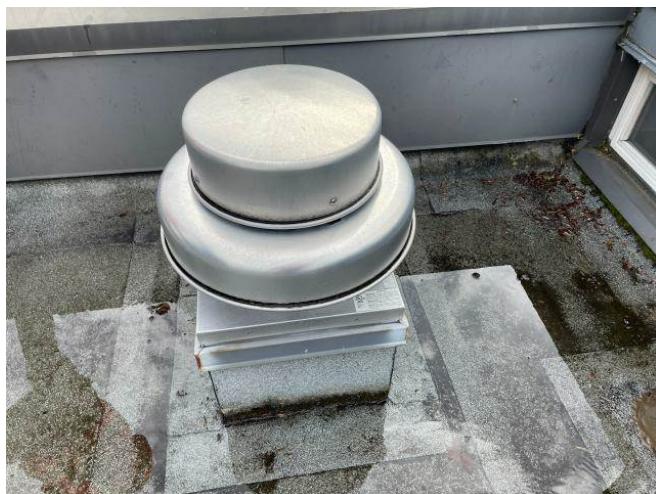
Photo #42: HVAC - Rooftop Exhaust Fan - Typical

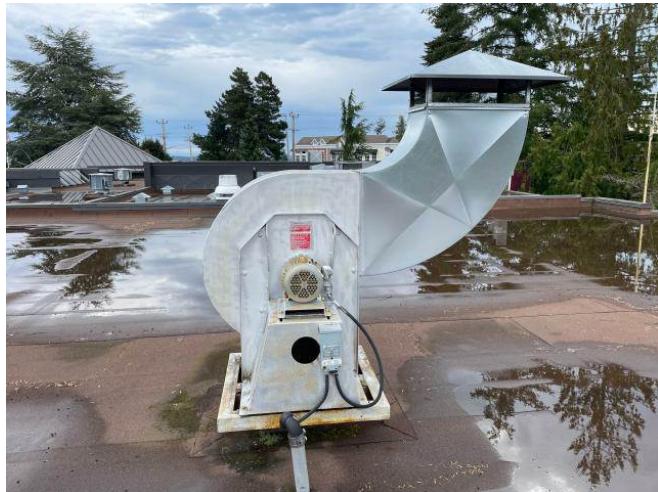
Photo #43: HVAC - Fire Department Apparatus Bay Exhaust Fan

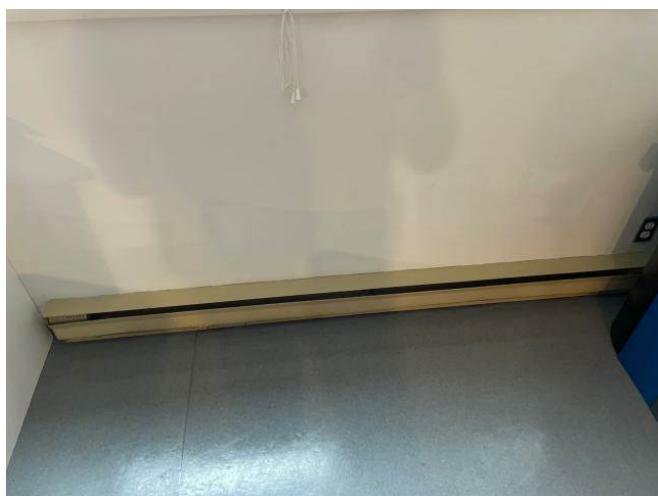
Photo #44: HVAC - Electric Baseboard Heater

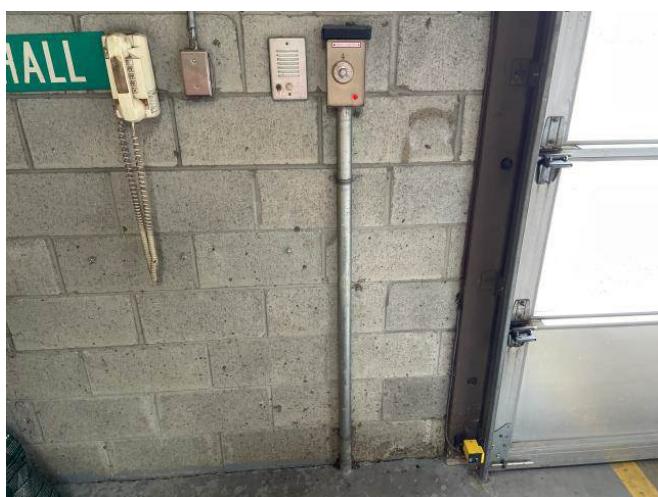
Photo #45: HVAC - Firehall In-Floor Heating Control

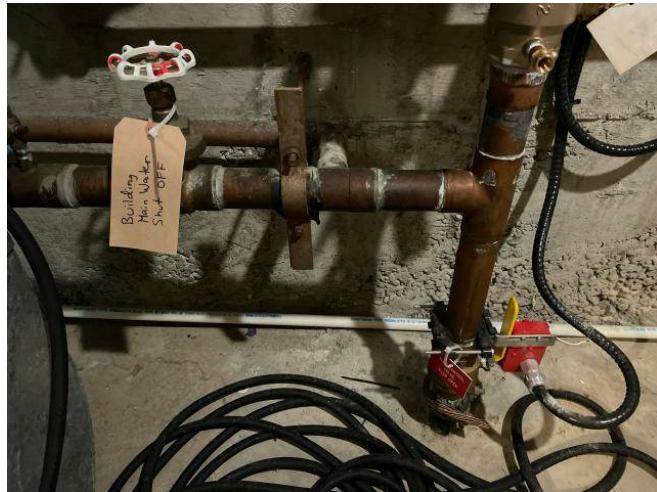
Photo #46: Incoming Water Service

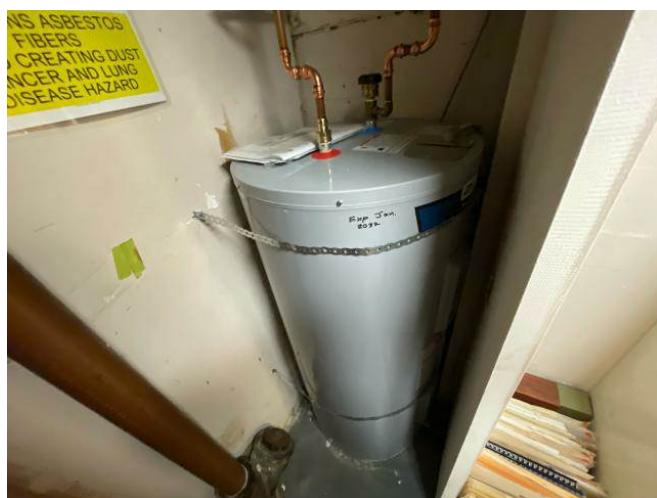
Photo #47: Domestic Hot Water Tank - Typical

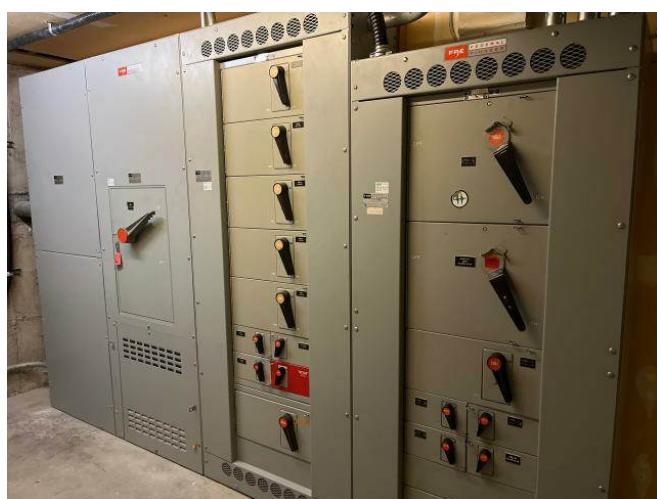
Photo #48: Electrical Main Switchgear

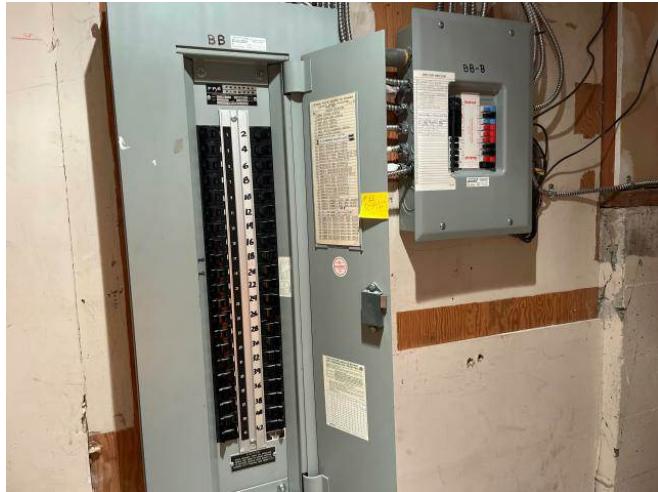
Photo #49: Electrical Panel - Typical

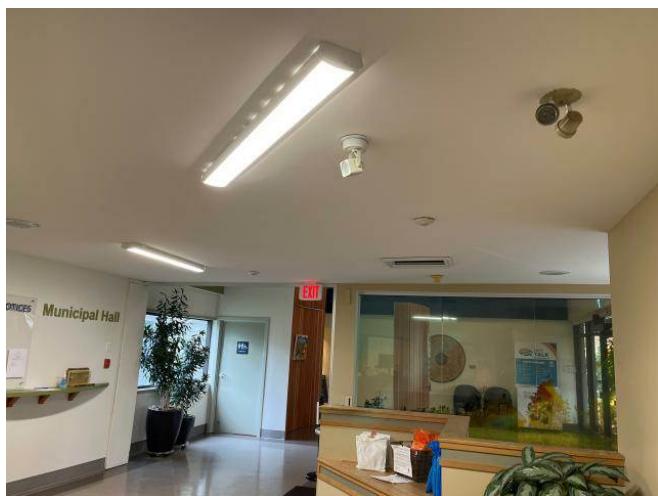
Photo #50: Lighting - Newer - LED

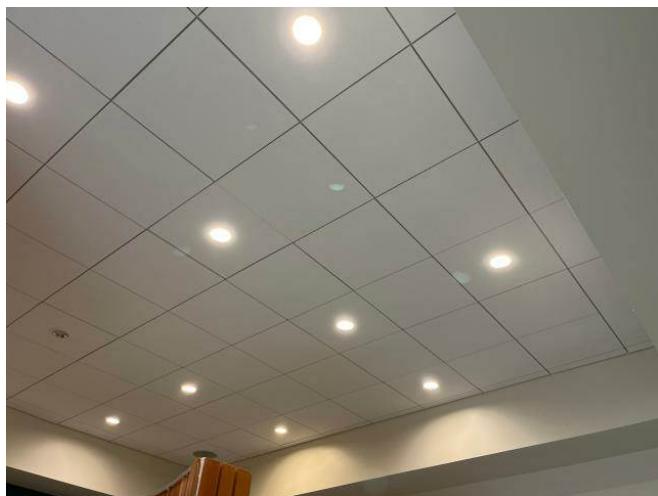
Photo #51: Lighting - Interior Recessed Fixtures

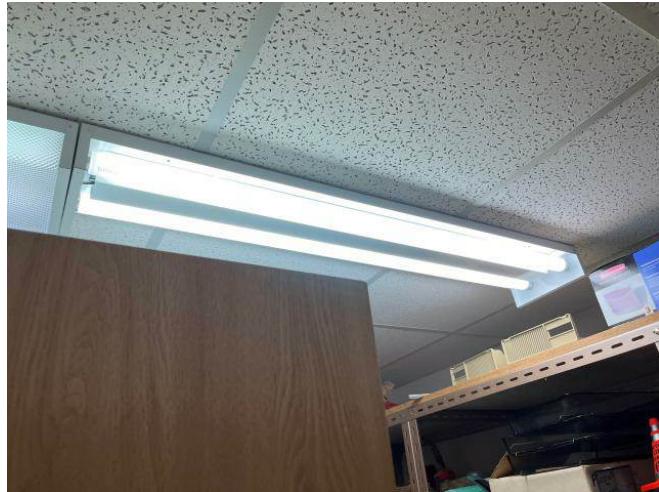
Photo #52: Lighting - Older - Florescent T12

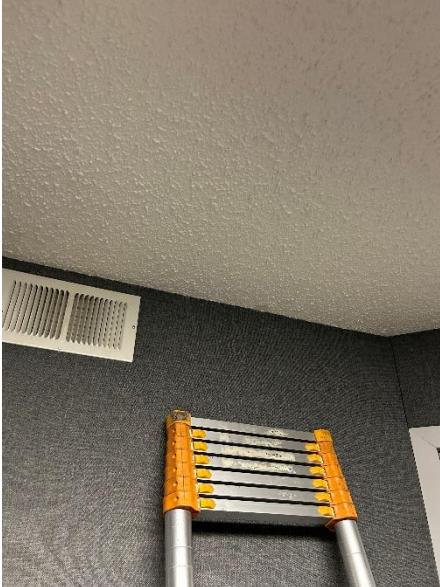
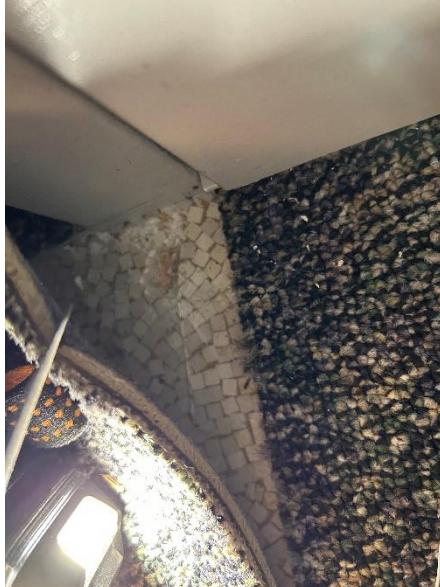
<p>Sample: 48738 - 1 Location: Main floor – Police Department – Interview room ceiling Description: Textured ceiling Asbestos: 1% Chrysotile</p>	<p>Sample: 48738 - 2 Location: Main floor – Police Department – Interview room – Under carpet Description: Sheet vinyl flooring Asbestos: 60% Chrysotile</p>
<p>No Photo Available</p>

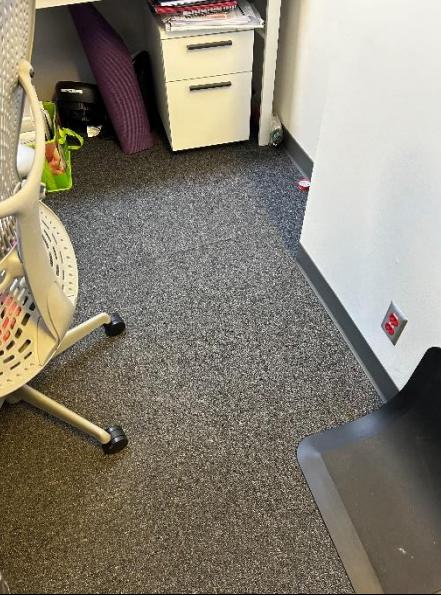
<p>No Photo Available</p>
<p>Sample: 48738 - 5 Location: Main floor – Police Department – Open office area outside interview room – Under carpet tile Description: Sheet vinyl flooring Asbestos: 60% Chrysotile</p>	<p>Sample: 48738 - 6 Location: Main floor – Police Department – Outside deputy chief's office Description: Ceiling tile Asbestos: None detected</p>
<p>No Photo Available</p>	<p>No Photo Available</p>
<p>Sample: 48738 - 7 Location: Main floor – Police Department – Outside deputy chief's office Description: Drywall joint compound Asbestos: None detected</p>	<p>Sample: 48738 - 8 Location: Main floor – Police Department – General office area – Under carpet Description: Sheet vinyl flooring Asbestos: 60% Chrysotile</p>

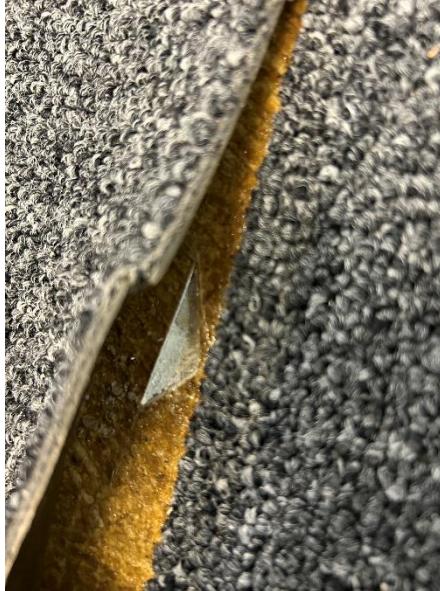
<p>Sample: 48738 - 9 Location: Main floor – Police Department – Office next to board room Description: Drywall joint compound Asbestos: None detected</p>	<p>Sample: 48738 - 10 Location: Main floor – Police Department – Communication room/ washroom Description: Sheet vinyl flooring Asbestos: 60% Chrysotile</p>
<p>No Photo Available</p>

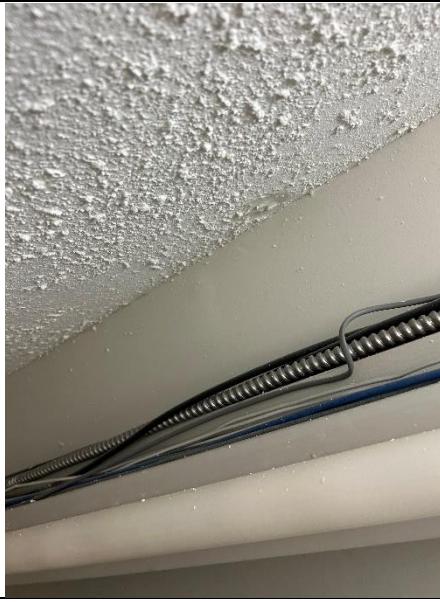
<p>Sample: 48738 - 11 Location: Main floor – Police Department – Office next to board room ceiling Description: Ceiling tile Asbestos: None detected</p>	<p>Sample: 48738 - 12 Location: Main floor – Police Department – Hall ceiling Description: Textured ceiling Asbestos: None detected</p>

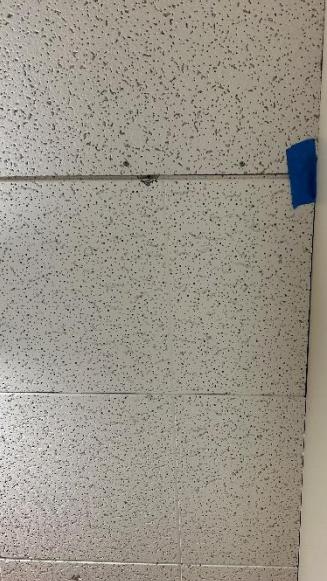
<p>Sample: 48738 - 13 Location: Main floor – Police Department – Hall storage room wall Description: Drywall joint compound Asbestos: None detected</p>	<p>Sample: 48738 - 14 Location: Main floor – Police Department – Community policing room wall Description: Drywall joint compound Asbestos: None detected</p>

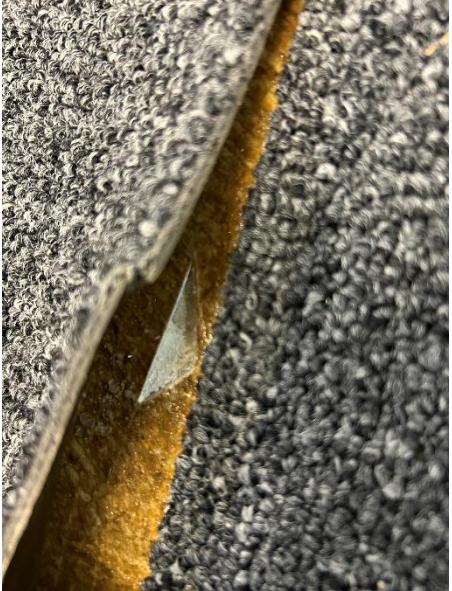
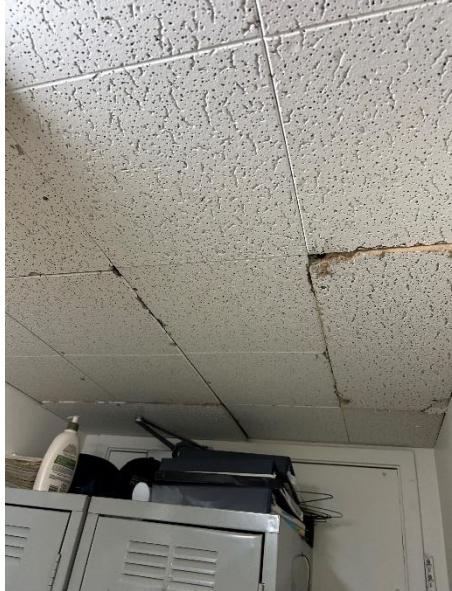
<p>Sample: 48738 - 15 Location: Main floor – Police Department – Community policing room – Under carpet Description: Sheet vinyl flooring Asbestos: 60% Chrysotile</p>	<p>Sample: 48738 - 16 Location: Main floor – Police Department – Stationery room ceiling Description: Ceiling tile Asbestos: None detected</p>

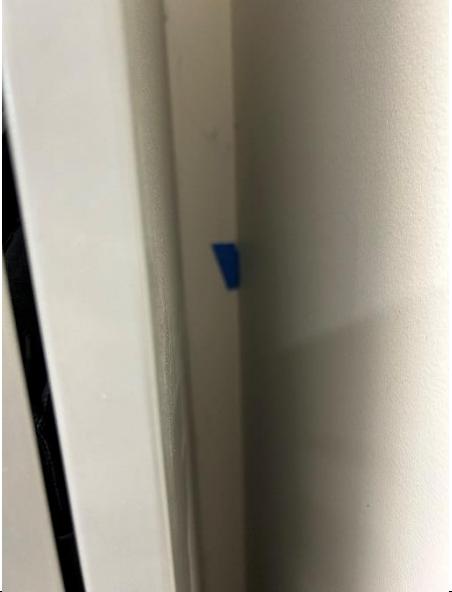
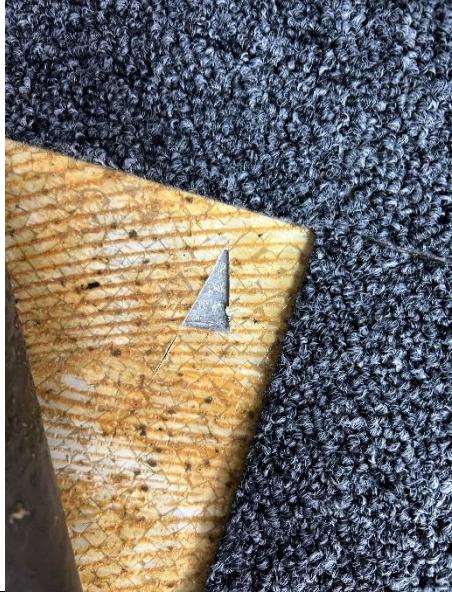
<p>Sample: 48738 - 17 Location: Basement – Police Department – Men's locker room – Under carpet Description: Sheet vinyl flooring Asbestos: 60% Chrysotile</p>	<p>Sample: 48738 - 18 Location: Basement – Police Department – Men's locker room ceiling Description: Ceiling tile Asbestos: None detected</p>

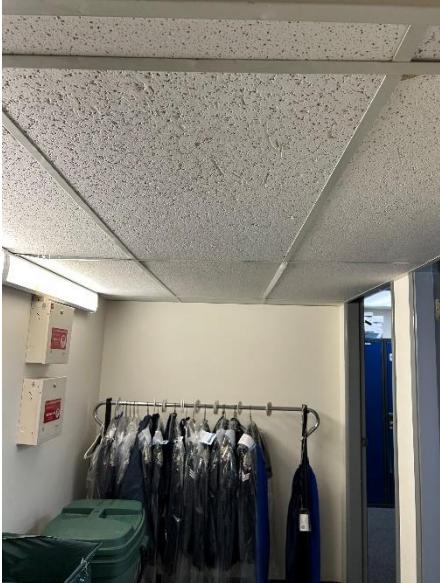
<p>Sample: 48738 - 19 Location: Basement – Police Department – Men's locker room wall Description: Drywall joint compound Asbestos: None detected</p>	<p>Sample: 48738 - 20 Location: Basement – Police Department – Women's locker room – Under carpet Description: Sheet vinyl flooring Asbestos: None detected</p>

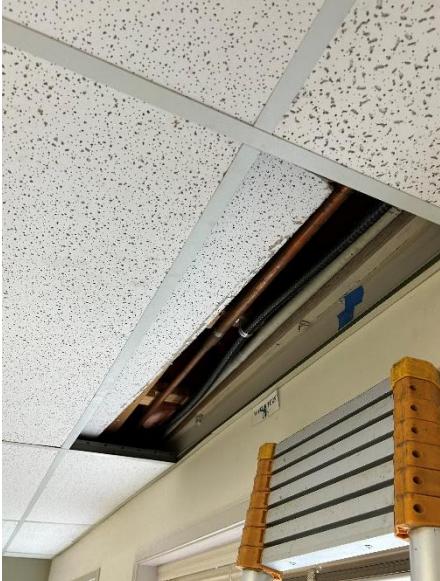
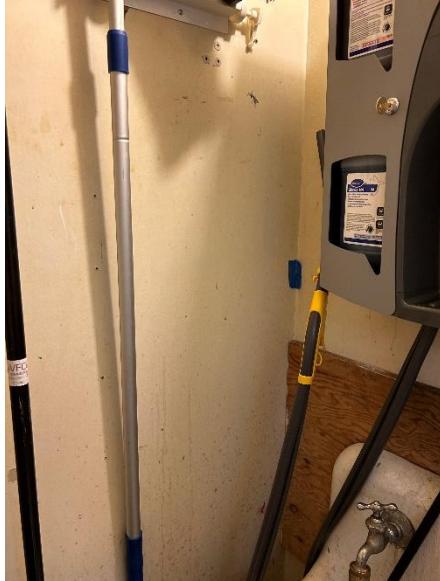
<p>Sample: 48738 - 23 Location: Basement – Municipal Hall – Kitchen Description: Sheet vinyl flooring Asbestos: 60% Chrysotile</p>	<p>Sample: 48738 - 24 Location: Basement – Municipal Hall – Kitchen wall Description: Drywall joint compound Asbestos: None detected</p>

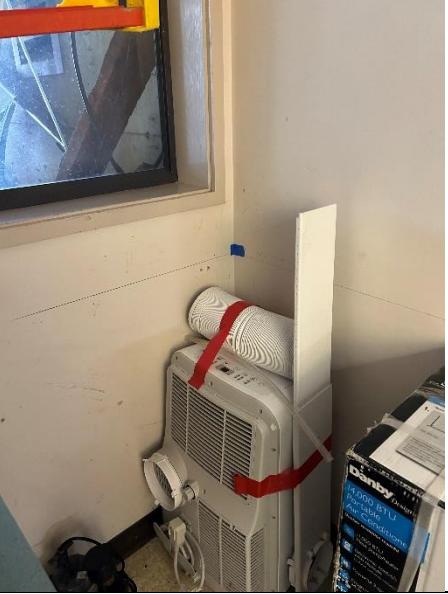
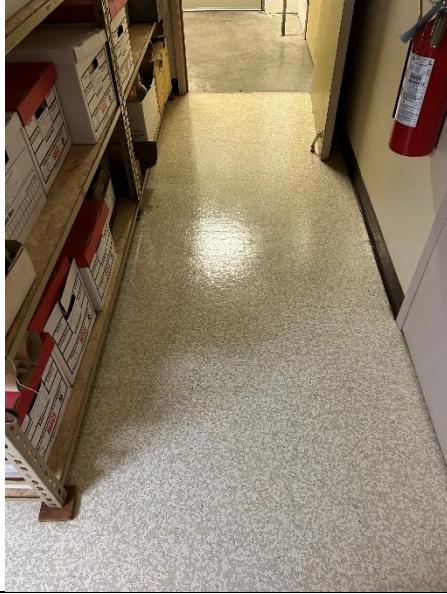
<p>Sample: 48738 - 27 Location: Basement – Municipal Hall – Back document storage room ceiling Description: Textured ceiling Asbestos: None detected</p>	<p>Sample: 48738 - 28 Location: Basement – Municipal Hall – Back document storage room floor Description: Vinyl floor tile Asbestos: 1% Chrysotile</p>

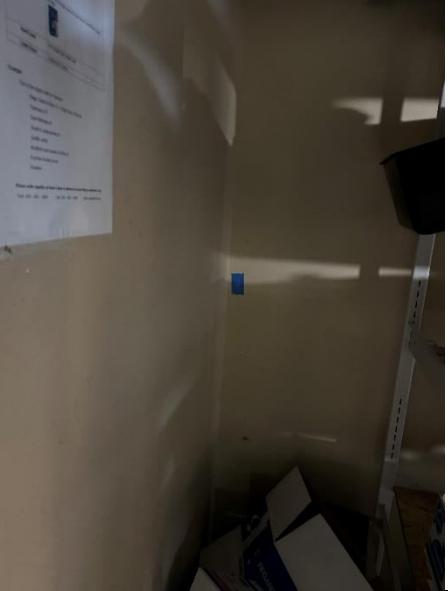
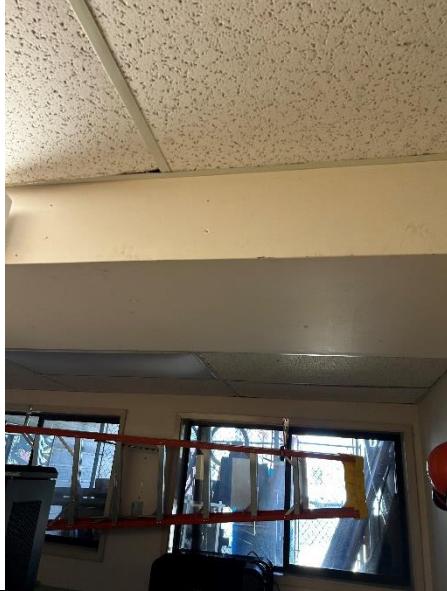
<p>Sample: 48738 - 29 Location: Basement – Municipal Hall – Workshop wall Description: Drywall joint compound Asbestos: None detected</p>	<p>Sample: 48738 - 30 Location: Basement – Municipal Hall – Custodian storage/workshop Description: Sheet vinyl flooring Asbestos: None detected</p>

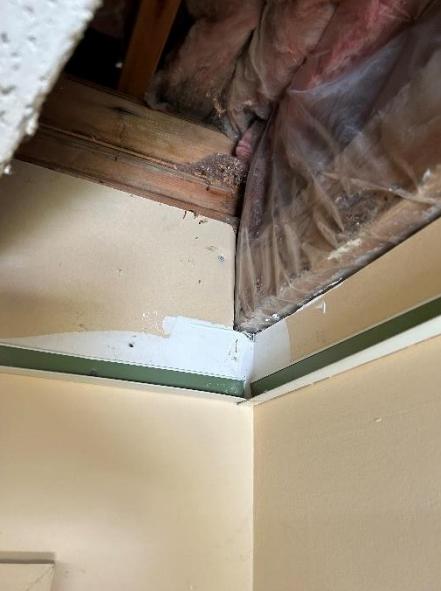
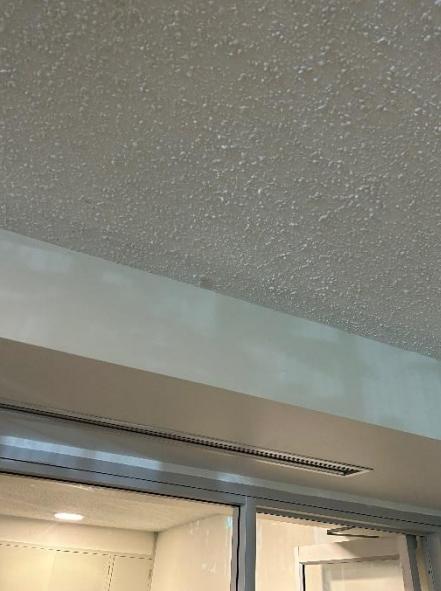
<p>Sample: 48738 - 33 Location: Basement – Municipal Hall – Furnace room – HVAC ducting Description: Mastic Asbestos: None detected</p>	<p>Sample: 48738 - 34 Location: Basement – Municipal Hall – Furnace room ceiling Description: Drywall joint compound Asbestos: None detected</p>

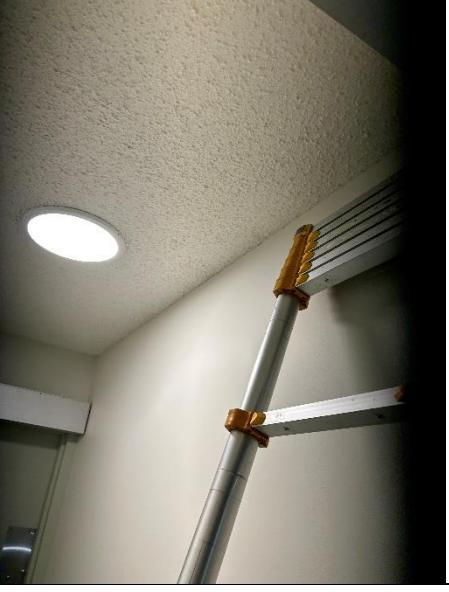
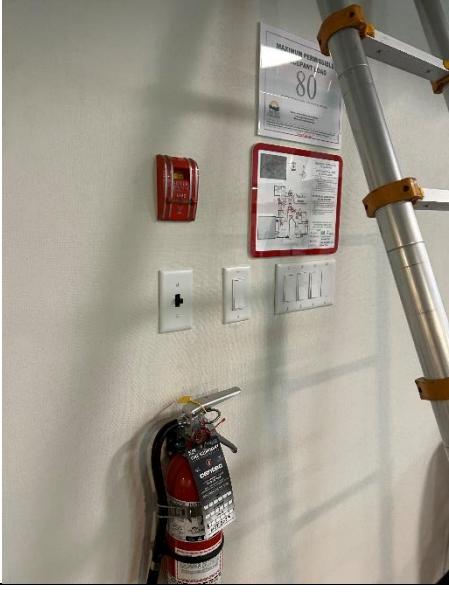
<p>Sample: 48738 - 35 Location: Basement – Municipal Hall – Planning #2 office wall Description: Drywall joint compound Asbestos: None detected</p>	<p>Sample: 48738 - 36 Location: Main floor – Municipal Hall – Council chambers – Lower ceiling Description: Textured ceiling/drywall joint compound Asbestos: 1% Chrysotile</p>

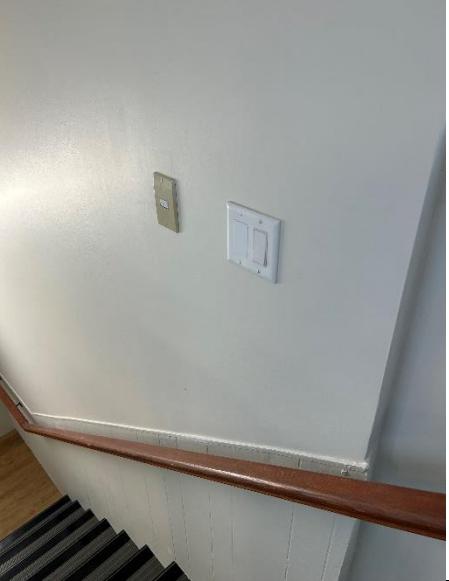
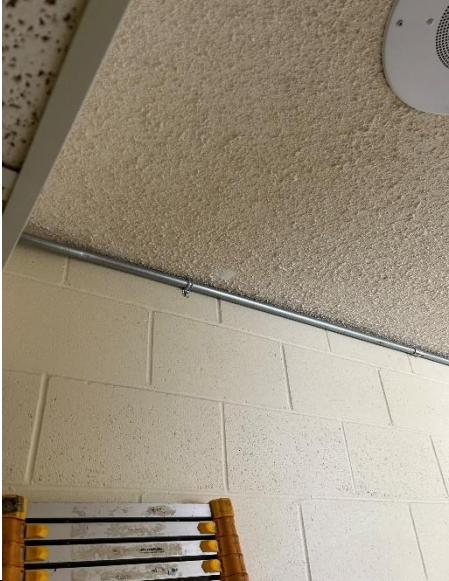
<p>Sample: 48738 - 37 Location: Main floor – Municipal Hall – Hall to washroom ceiling Description: Textured ceiling/drywall joint compound Asbestos: 1% Chrysotile</p>	<p>Sample: 48738 - 38 Location: Main floor – Municipal Hall – Council chambers wall Description: Drywall joint compound Asbestos: None detected</p>

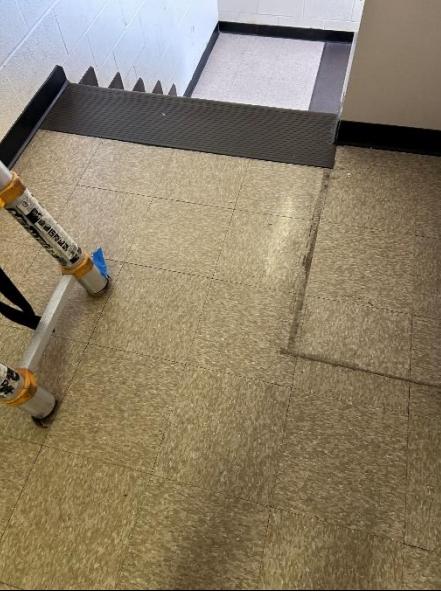
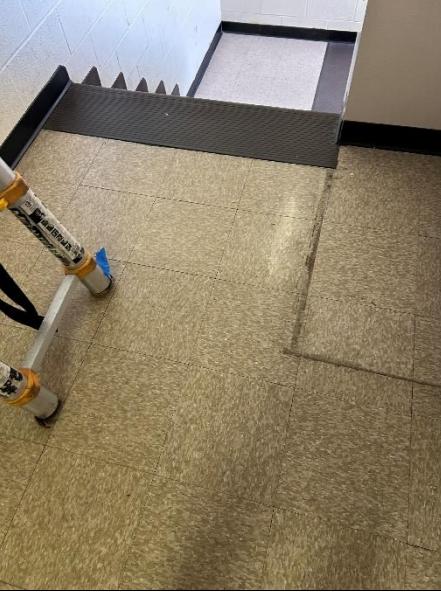
<p>Sample: 48738 - 39 Location: Main floor – Municipal Hall – Stairwell main hall wall Description: Drywall joint compound Asbestos: None detected</p>	<p>Sample: 48738 - 40 Location: Main floor – Municipal Hall – Council chambers corridor ceiling Description: Textured ceiling Asbestos: 1% Chrysotile</p>
