Central Saanich Municipal Building

Building Code Compliance & Accessibility

Building Assessment Report

2025-05-15

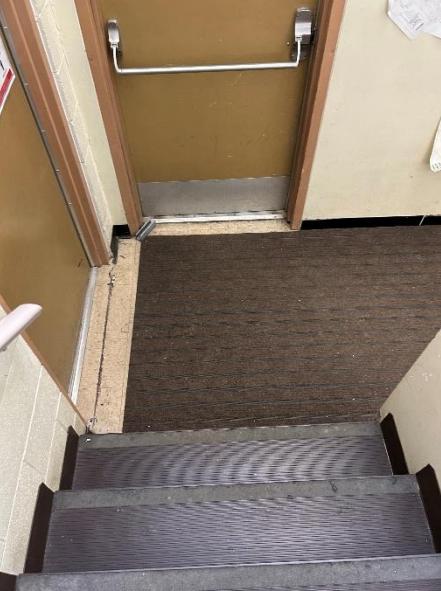
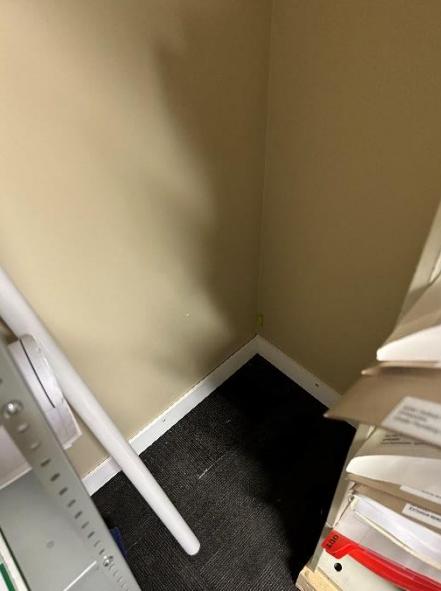
<p>Sample: 48738 - 41 Location: Main floor – Municipal Hall – Council chambers corridor floor – Top layer Description: Vinyl floor tile Asbestos: None detected</p>	<p>Sample: 48738 - 42 Location: Main floor – Municipal Hall – Council chambers corridor floor – Lower layer Description: Vinyl floor tile Asbestos: 2% Chrysotile</p>

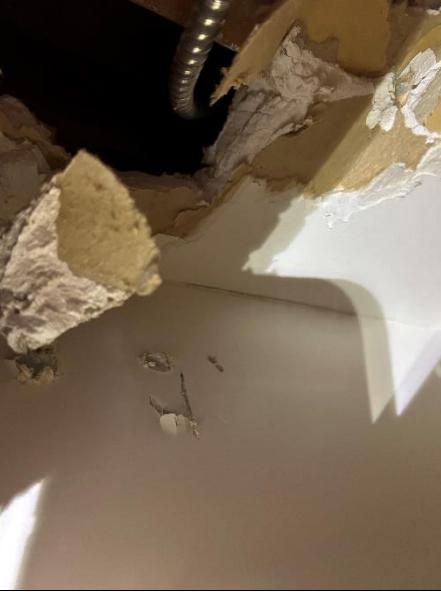
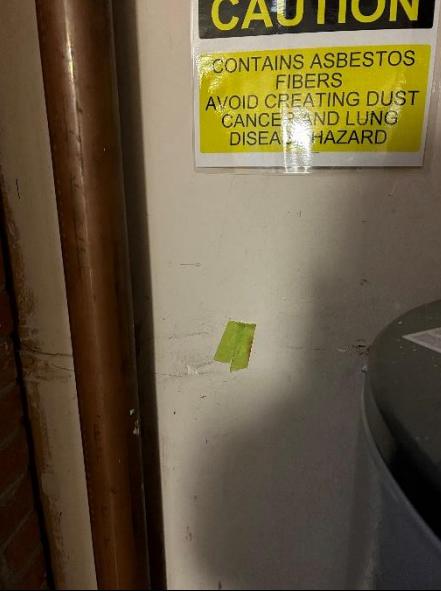
- The asbestos containing vinyl floor tiles in the stairwell off the Municipal Council Chambers was noted to be cracking at the time of this investigation. We recommend these floor tiles be removed or encapsulated to prevent further deterioration.

<p>Sample: 48738 - 43 Location: Main floor – Municipal Hall – Stairwell and bottom of stairs Description: Vinyl floor tile Asbestos: 2% Chrysotile</p>	<p>Sample: 48738 - 44 Location: Basement – Planning Department – Document storage room wall Description: Drywall joint compound Asbestos: None detected</p>

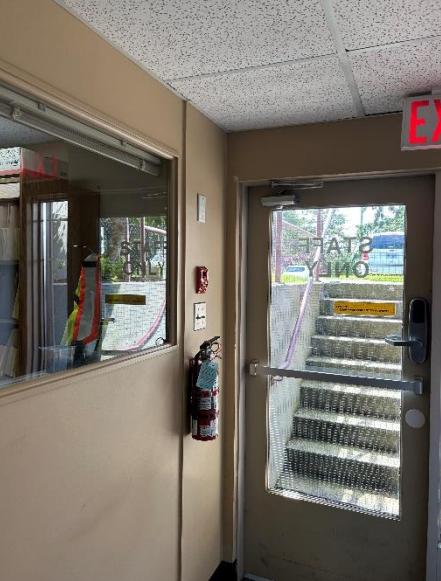
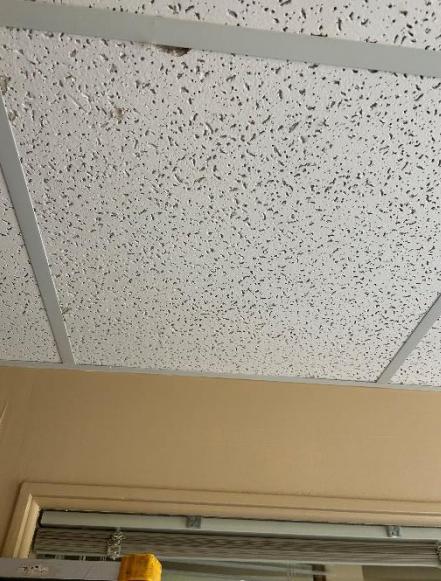
- The drywall with asbestos containing drywall joint compound above the ceiling tiles in the basement planning department corridor was observed to be damaged at the time of this investigation. We recommend the damaged drywall be removed or encapsulated.

<p>Sample: 48738 - 45 Location: Basement – Planning Department – Corridor – Above ceiling tile Description: Drywall joint compound Asbestos: 1% Chrysotile</p>	<p>Sample: 48738 - 46 Location: Basement – Planning Department – File storage vault closet Description: Drywall joint compound Asbestos: 1% Chrysotile</p>

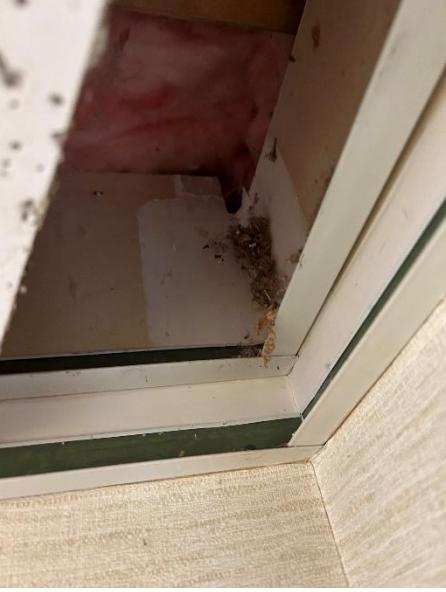
<p>Sample: 48738 - 47 Location: Basement – Planning Department – Corridor at exit Description: Drywall joint compound Asbestos: 1% Chrysotile</p>	<p>Sample: 48738 - 48 Location: Basement – Planning Department – Corridor ceiling Description: Ceiling tile Asbestos: None detected</p>

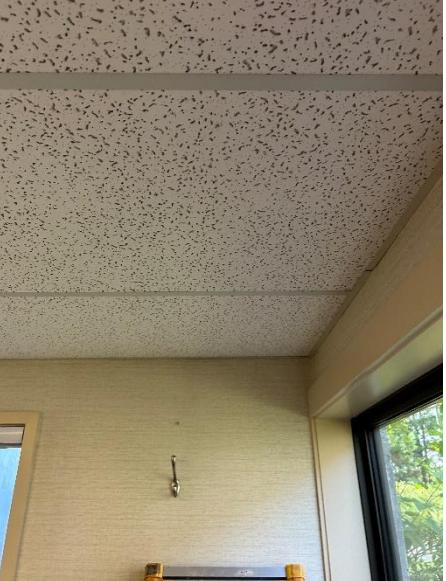
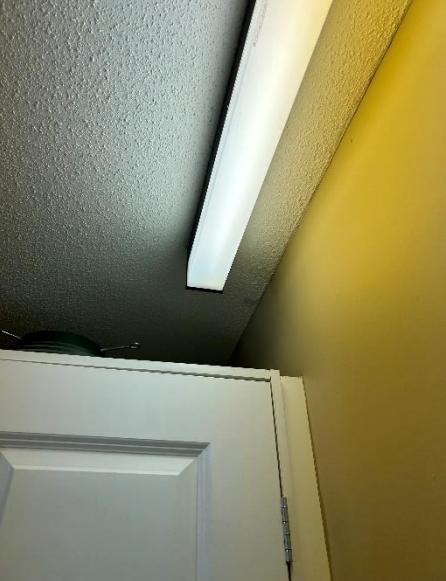
<p>Sample: 48738 - 49 Location: Basement – Planning Department - Vault Description: Sheet vinyl flooring Asbestos: None detected</p>	<p>Sample: 48738 - 50 Location: Basement – Planning Department – Planning #1 office Description: Drywall joint compound Asbestos: None detected</p>

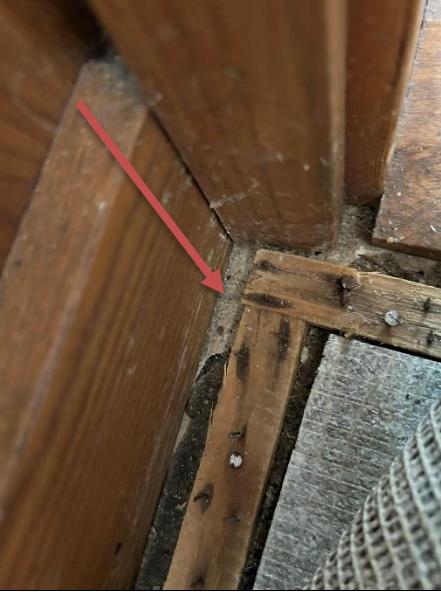
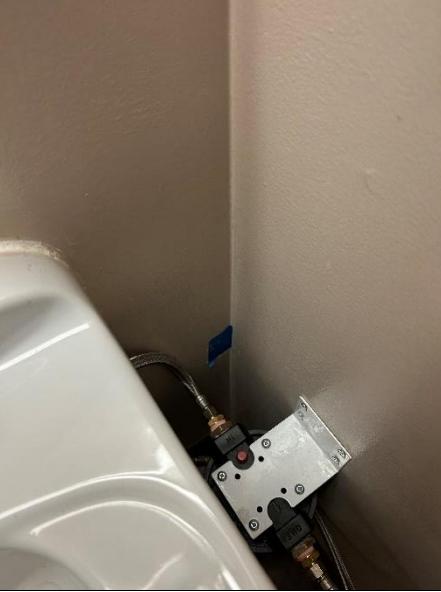
<p>Sample: 48738 - 51 Location: Basement – Planning Department – Planning #1 office Description: Ceiling tile Asbestos: None detected</p>	<p>Sample: 48738 - 52 Location: Main floor – Planning Department – Corridor at exit ceiling Description: Textured ceiling Asbestos: None detected</p>

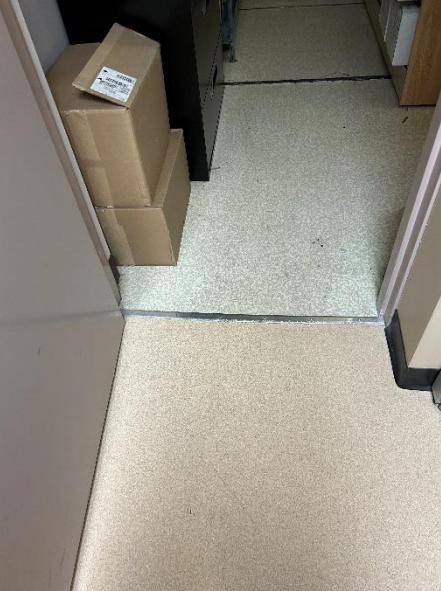
<p>Sample: 48738 - 53 Location: Main floor – Planning Department – Corporate services office Description: Vinyl floor tile Asbestos: 2% Chrysotile</p>	<p>Sample: 48738 - 54 Location: Main floor – Planning Department – Staff washroom wall Description: Drywall joint compound Asbestos: 1% Chrysotile</p>

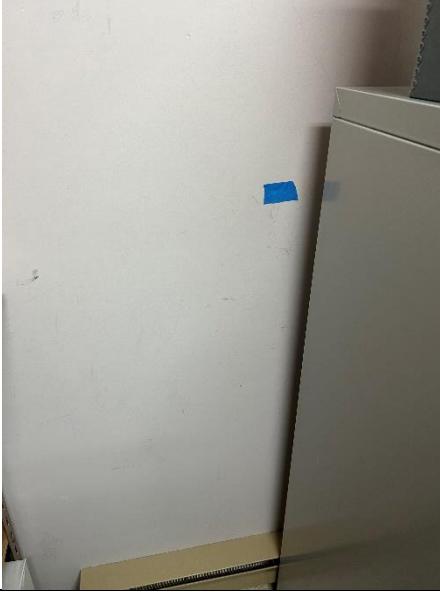
<p>Sample: 48738 - 55 Location: Main floor – Planning Department - Vault Description: Sheet vinyl flooring Asbestos: None detected</p>	<p>Sample: 48738 - 56 Location: Main floor – Planning Department – Server room – Top layer Description: Sheet vinyl flooring Asbestos: None detected</p>

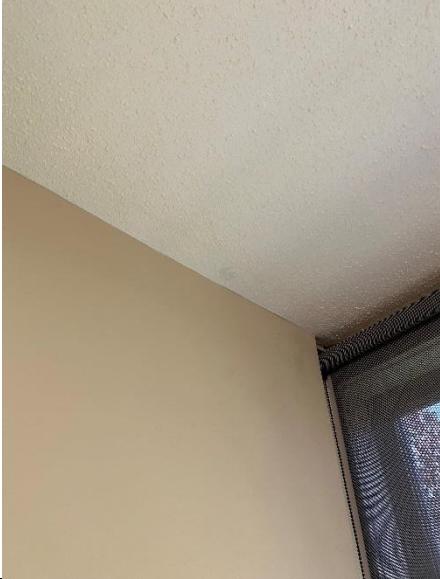
<p>Sample: 48738 - 57 Location: Main floor – Planning Department – Vault wall Description: Drywall joint compound Asbestos: None detected</p>	<p>Sample: 48738 - 58 Location: Main floor – Planning Department – Office #2 wall Description: Drywall joint compound Asbestos: 1% Chrysotile</p>

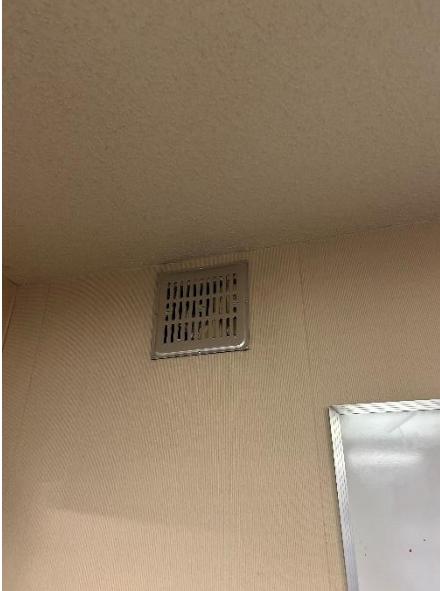
<p>Sample: 48738 - 59 Location: Main floor – Planning Department – Office #2 ceiling Description: Textured ceiling Asbestos: None detected</p>	<p>Sample: 48738 - 60 Location: Main floor – Planning Department – Office #3 wall Description: Drywall joint compound Asbestos: None detected</p>

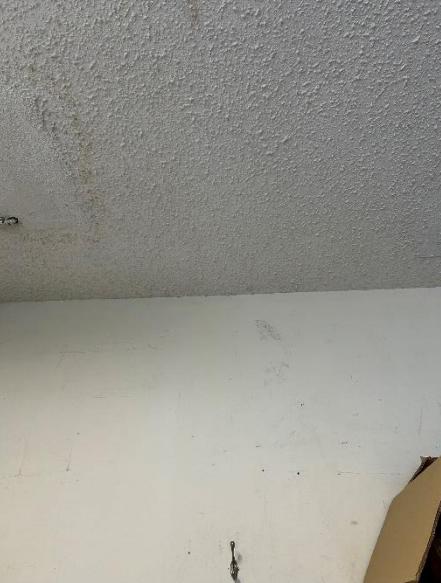
<p>Sample: 48738 - 65 Location: Basement – Firehall Lounge – Lounge ceiling Description: Textured ceiling/drywall joint compound Asbestos: None detected</p>	<p>Sample: 48738 - 66 Location: Basement – Firehall Lounge – Corridor ceiling Description: Textured ceiling Asbestos: 1% Chrysotile</p>

- We recommend that any textured ceiling be painted to help prevent unintentional damage/disturbance.
- All other identified asbestos containing materials were observed to be in good condition. We recommend that asbestos containing materials be monitored in place.

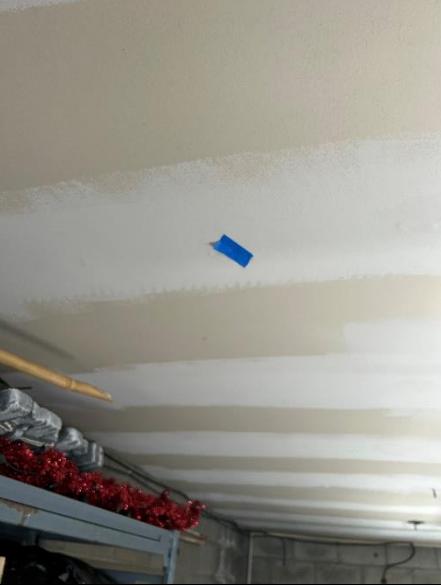
<p>Sample: 48738 - 67 Location: Basement – Workshop ceiling Description: Textured ceiling Asbestos: 1% Chrysotile</p>	<p>Sample: 48738 - 68 Location: Basement – Apparatus ceiling Description: Drywall joint compound Asbestos: None detected</p>

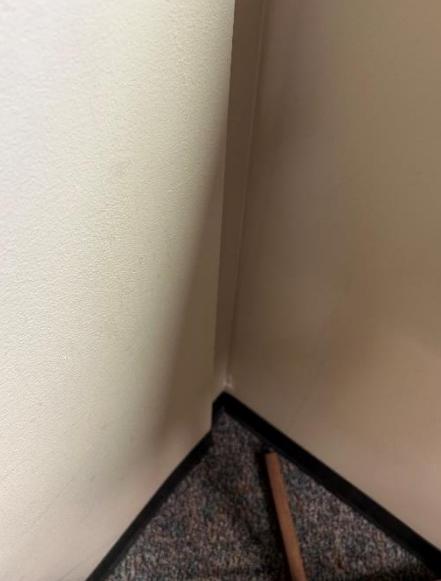
<p>Sample: 48738 - 71 Location: Exterior – Over vault foundation Description: Parging Asbestos: None detected</p>	<p>Sample: 48738 - Pb1 Location: Police Department Walls Description: Cream Paint Lead Content: <6μg/g</p>

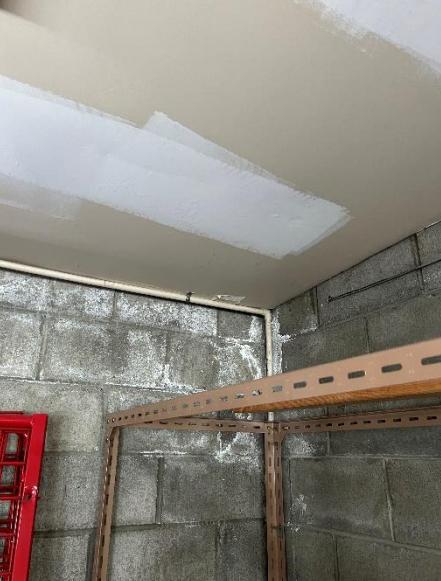
<p>Sample: 48738 – Pb2 Location: Municipal Hall Basement Planning Department Description: Cream Paint Lead Content: <7μg/g*</p>	<p>Sample: 48738 – Pb4 Location: Firehall Washroom Description: Cream Paint Lead Content: <9μg/g</p>

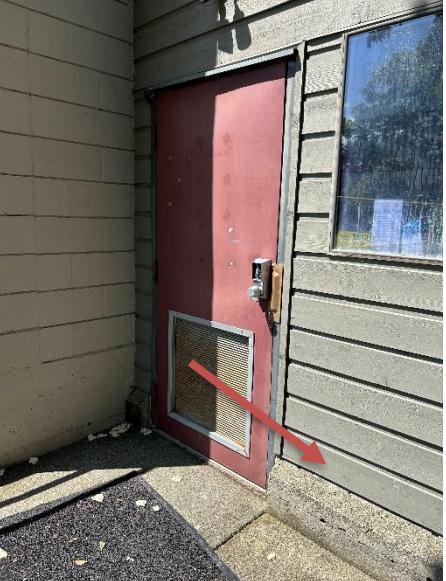
<p>Sample: 48738 – Pb5 Location: Apparatus Ceiling Description: Beige Paint Lead Content: <5μg/g</p>	<p>Sample: 48738 – Pb6 Location: Exterior - Firehall Workshop Door Description: Red Paint Lead Content: 1370μg/g</p>

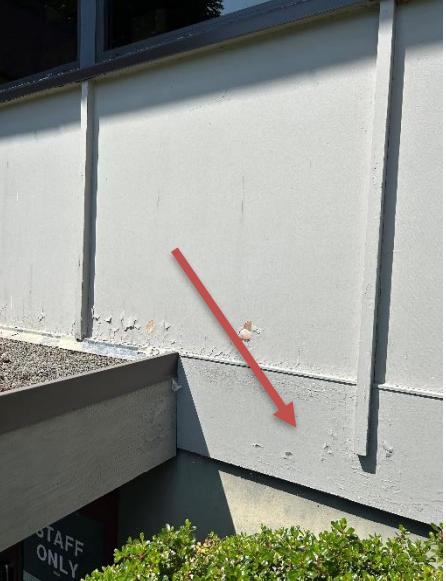
<p>Sample: 48738 – Pb7 Location: Exterior Siding Outside Firehall Lounge Description: Taupe Paint Lead Content: 4620μg/g*</p>	<p>Sample: 48738 – Pb8 Location: Exterior Municipal Hall Siding Description: Taupe Paint Lead Content: 15100μg/g*</p>
